TRUE INSPECTION

Inspection Report

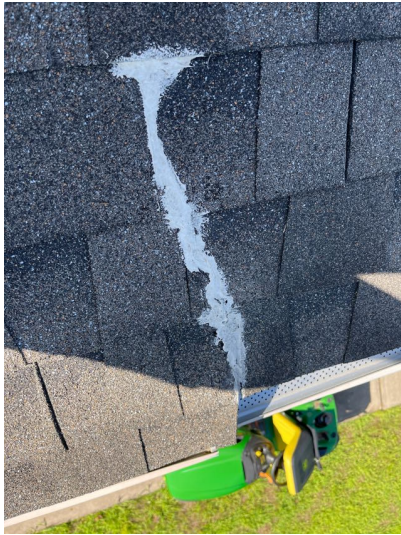
This is at the back of the home where the pool section meets the main house. Recommend roofing contractor, inspect and repair. Currently there is a silicone product in use. However, silicone is not a reliable sealant in this area and it is already breaking down on the lower section of the shingle. This is a potential area where leaks can occur and cause roof damage. Recommend repair ASAP.

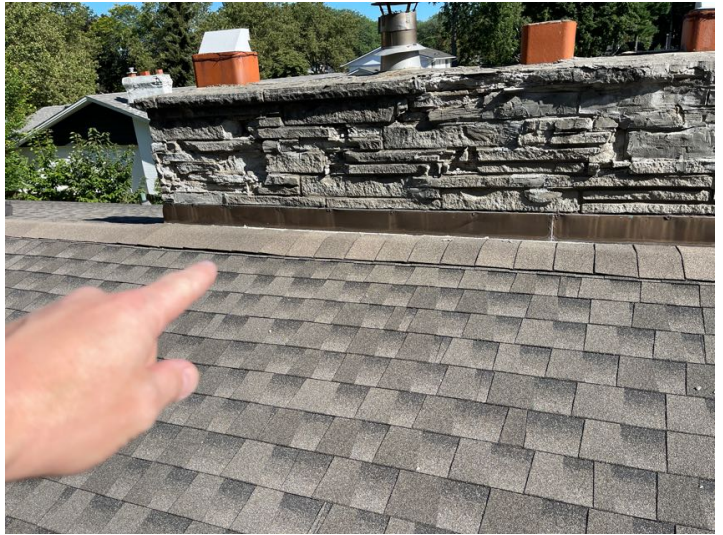
Some of the ridge shingles near the chimney are loose. Recommend a roofing contractor reattach so that they do not come off during high winds. You can repair these yourself by putting a roof mastic underneath the shingles and temporarily putting some bricks to hold them in place. The brick should be removed the following day so that they do not accidentally come off the roof and causing injury to someone.

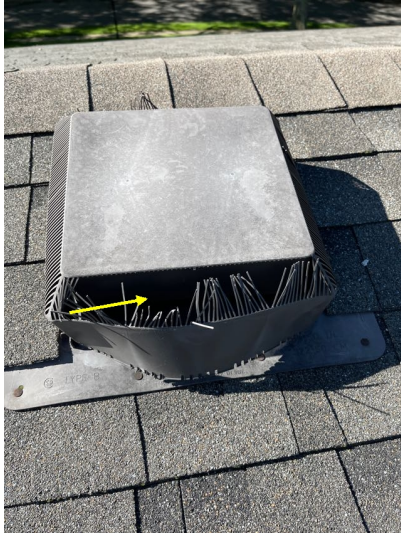
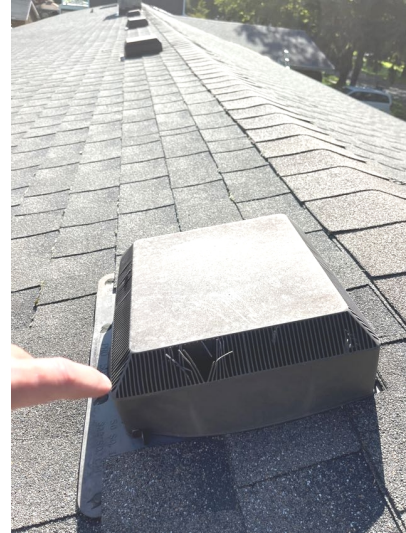
Two of the roof vents to the left of the chimney are damaged and should be replaced

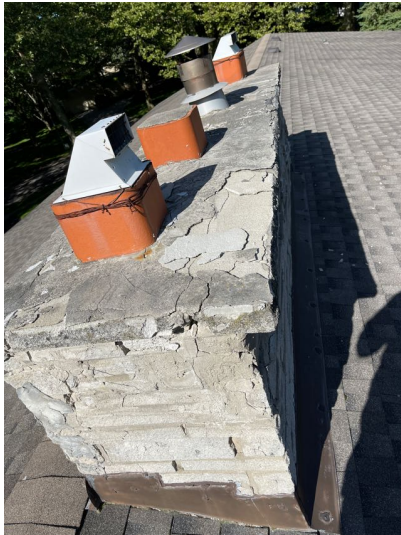
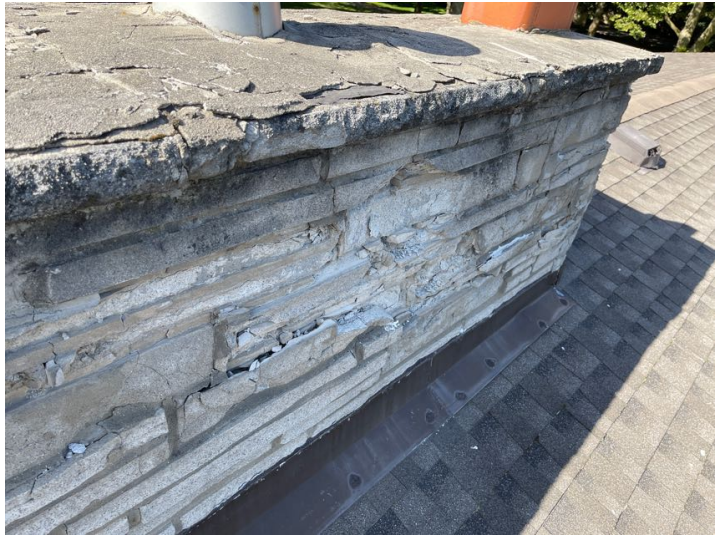
• **The chimney has for flues. One of them is cemented off. The chimney and crown are in very poor condition and will need to be replaced. Recommend mason, evaluate and replace/repair.**

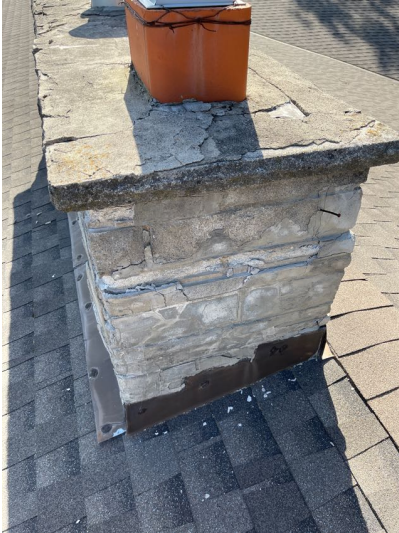
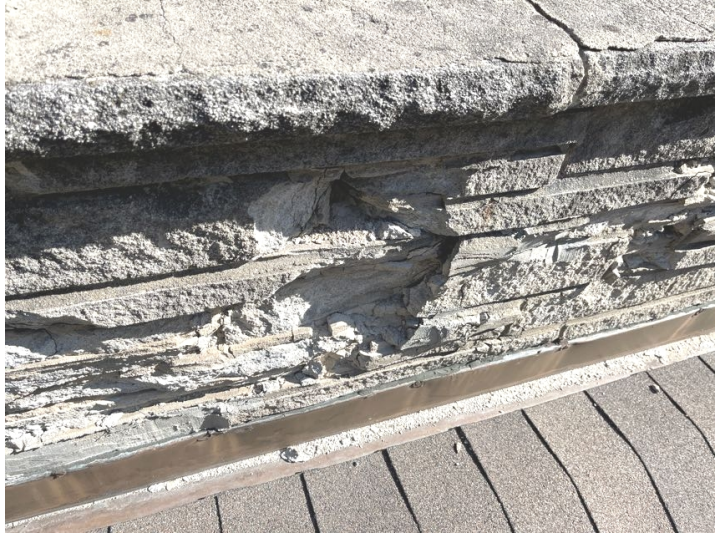
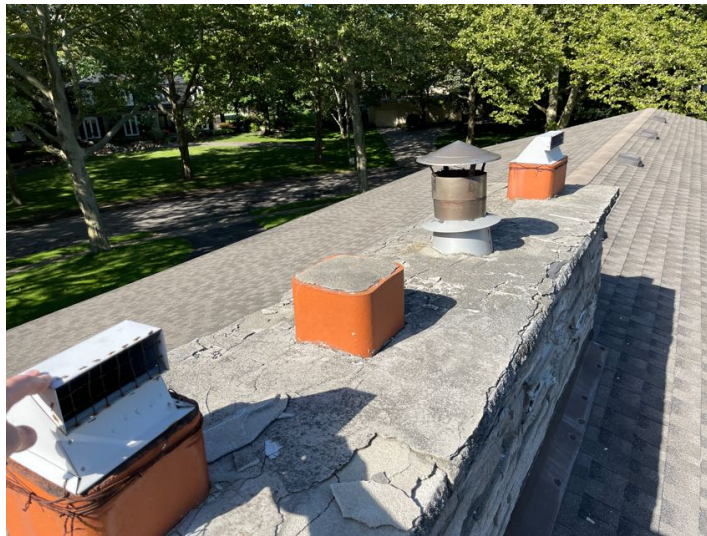
The two flues with the white vents at the top, are not attached to a liner or anything.

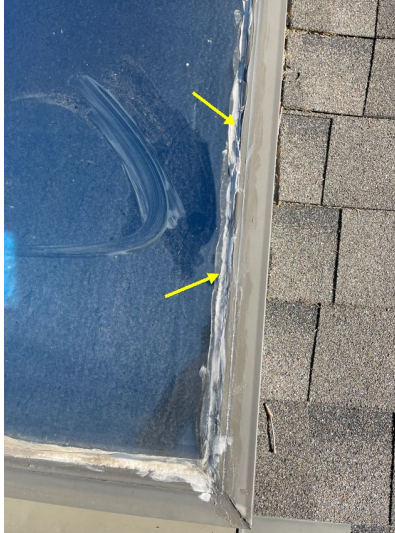
There are six skylights over the pool area. The skylights are older, and they all have multiple layers of silicone, some clear, and some white added. Recommend annual inspection and resealing as needed.

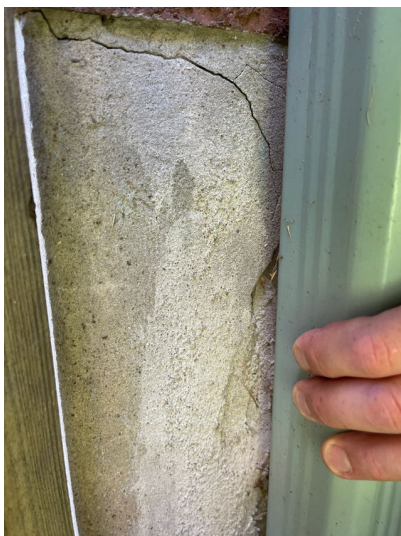
There is a corner, wedge crack behind the downspout at the left side of the home towards the rear.

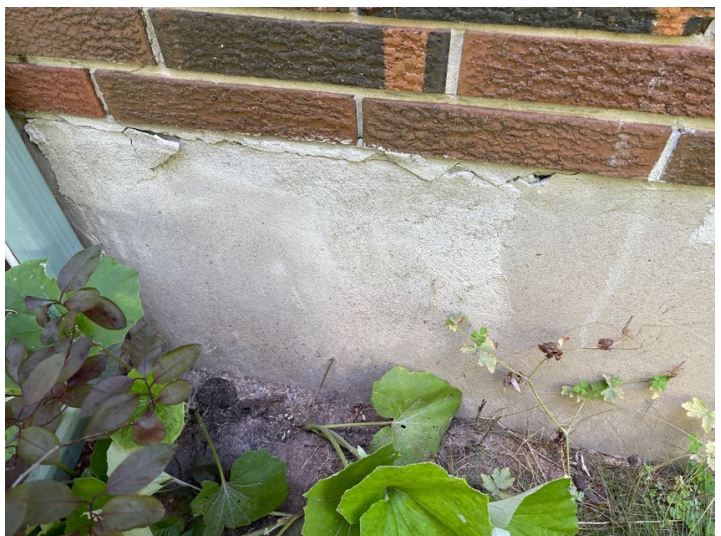
There is some damaged parging. This picture is on the left side of the home.

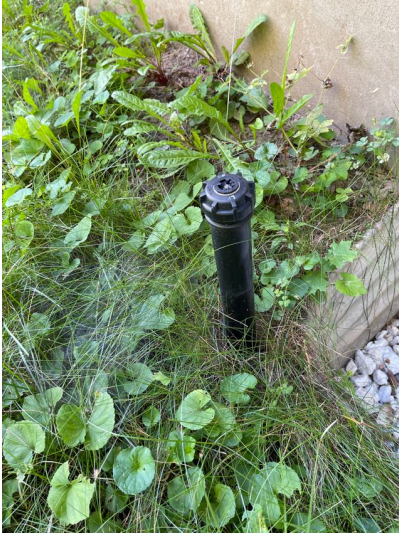
There is a sprinkler system in place. Be sure to check on the sprinklers are running that there is no water being sprayed against the foundation. If there is any water sprayed against the foundation sprinklers should be adjusted.

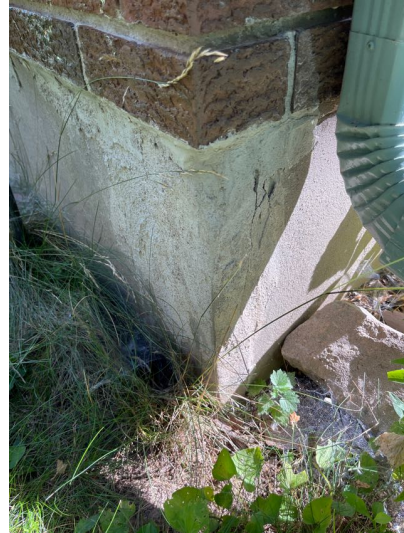
Corner wedge crack, front left corner of the home.

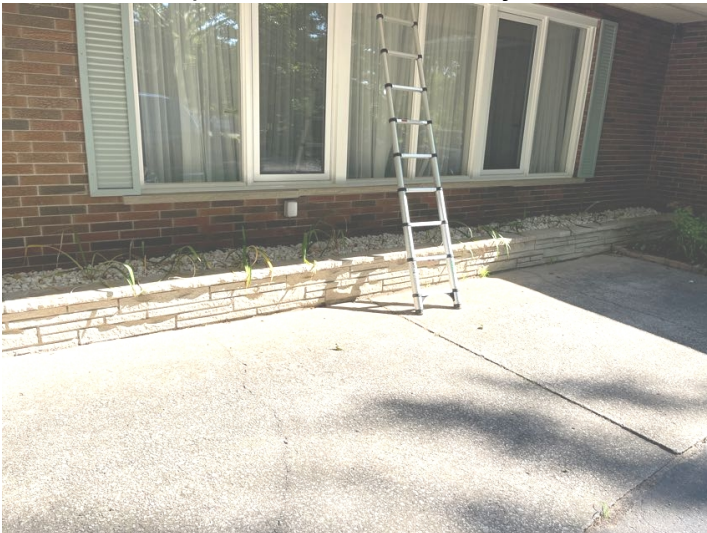
Some areas of the foundation are not visible for inspection as shown in the picture.

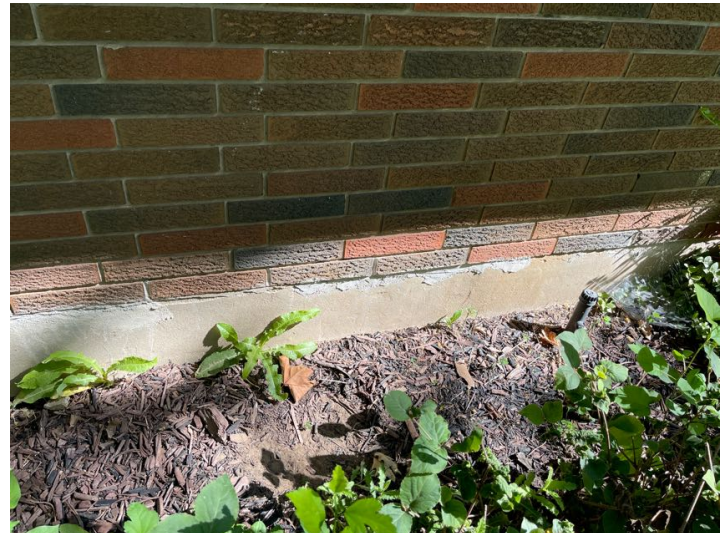
Front of home towards the left. The purging here is damaged. There is some damaged purging in several areas that has been unprofessionally patched. Recommend Mason inspect, and repair purging where needed.

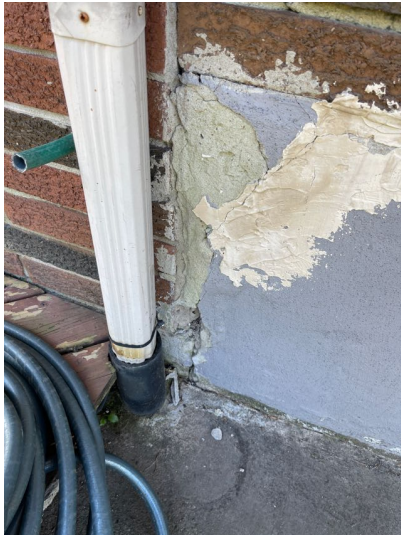
Rear section of the home where the home and pool room meet at this section.

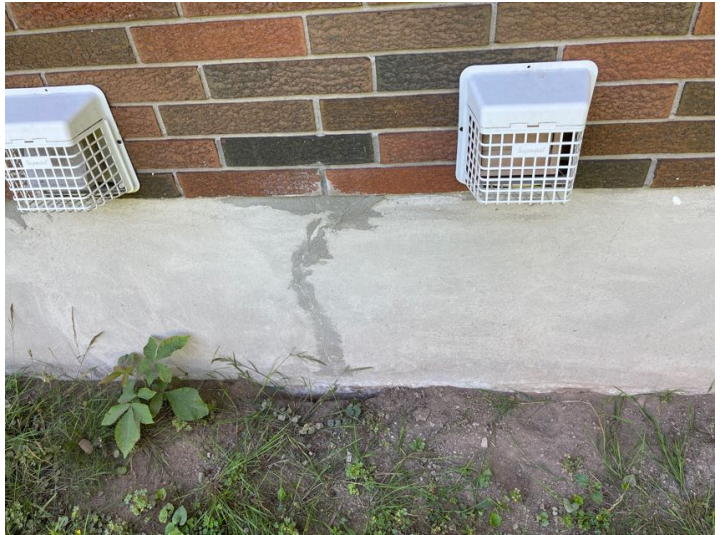
This crack in the parging. Someone has tried to repair it however, the parging has delaminated and detached from the concrete wall. This is at the back of the home. Recommend re-parging in areas where needed.

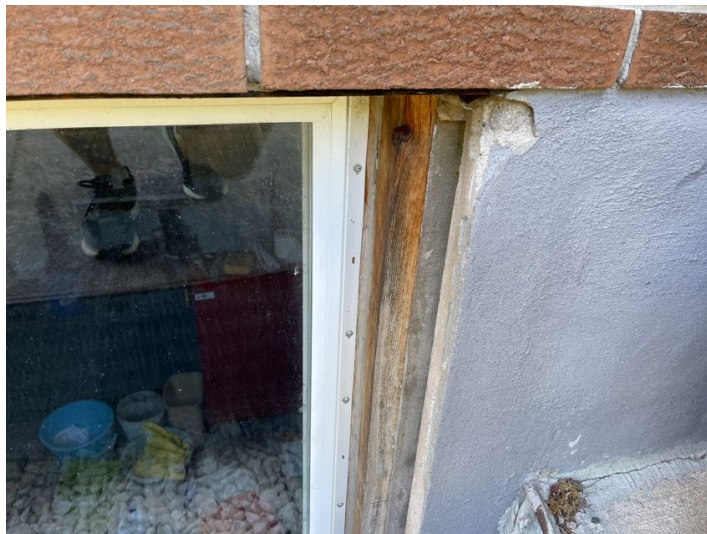
The wood framing around the foundation windows, should be either stained or capped with aluminum to protect them from rotting

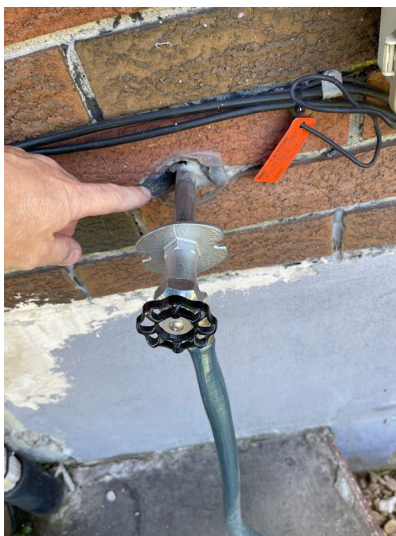
Recommend sealing this large gap, so that pests and water do not enter into the home

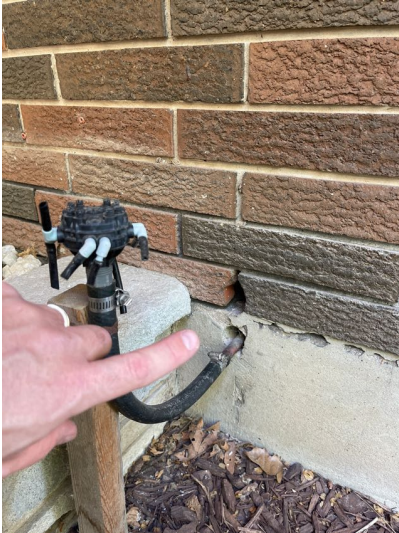
There are voids in the foundation in the brick work at the front of the home, where the pool building meets the main house. Recommend sealing these areas up to keep moisture and pests out of the home.

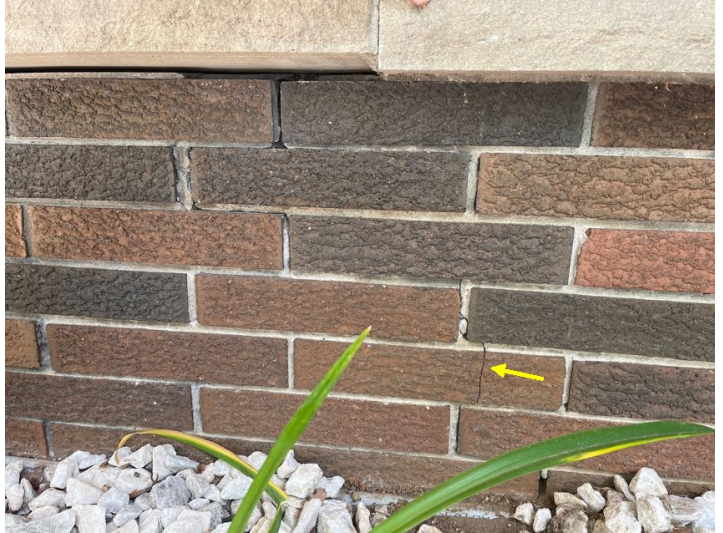
There is a crack in the brick, as well as several bricks with missing mortar in this location at the front of the home underneath the front living room windows. Recommend sealing this and re-mortering where needed.

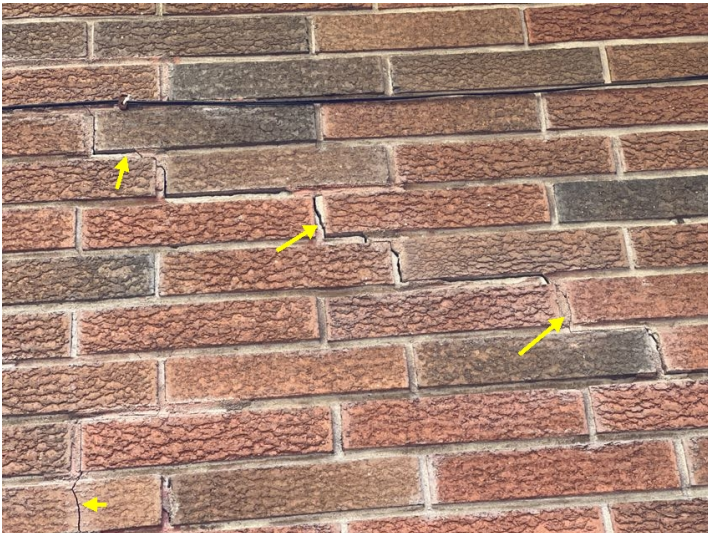
There are some areas above the garage door and beside the garage door that have cracks in the mortar joints. Recommend mason repoint.

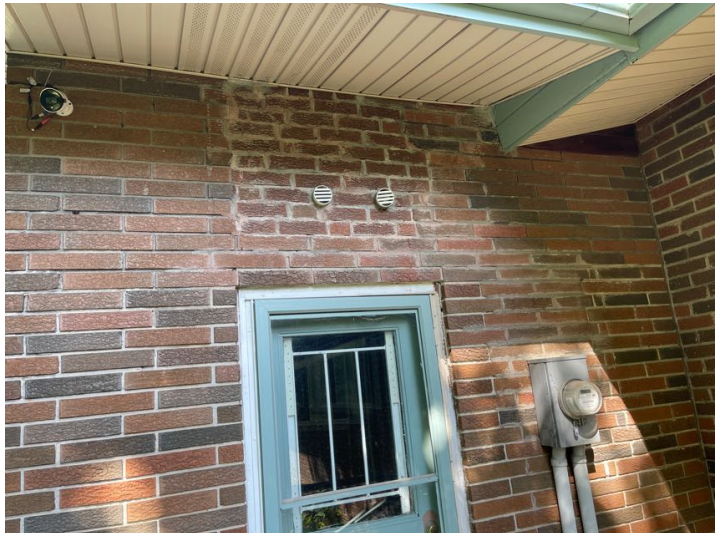
Previously repaired brick mortar. The repairs are noticeable, and not very aesthetically pleasing. Amateurish workmanship. Other than appearance the repair is acceptable.

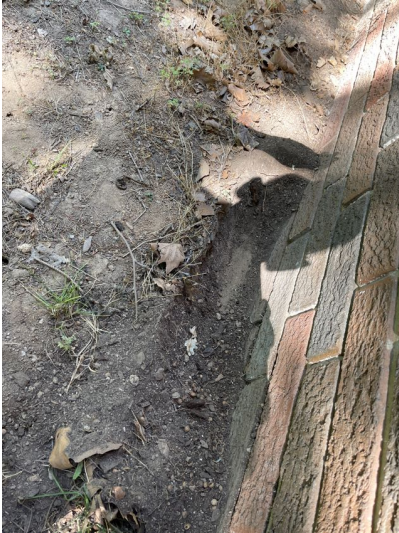
There is a layer of bricks at the front area of the pool room. These bricks are not designed to be below grade. This is difficult because to regrade the area so that the soil is below the bricks is going to bring the grade level down to low. recommend working with experienced contractor or mason to install a membrane or other barrier in this area so that the bricks are not exposed to constant moisture.

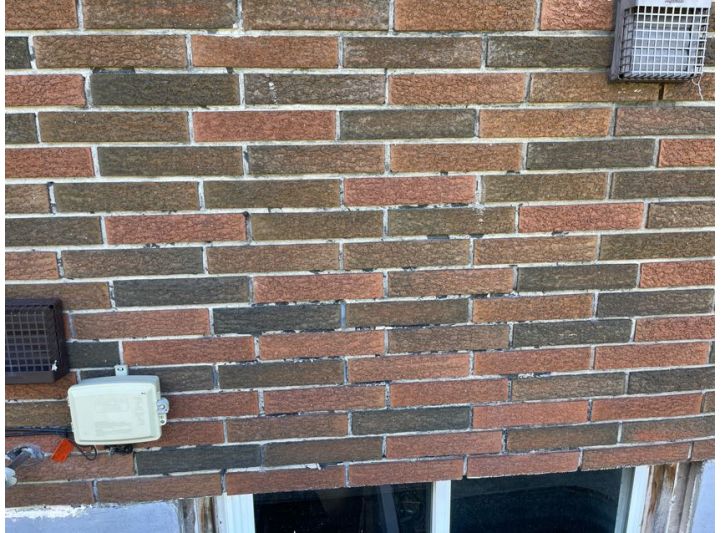
At the back of the home as shown in the picture, there is dark areas and light areas of this mortar. Some of the mortar is coming loose. This is because someone had tried to re-mortar this section incorrectly. Recommend Mason inspect and re-mortar where needed.

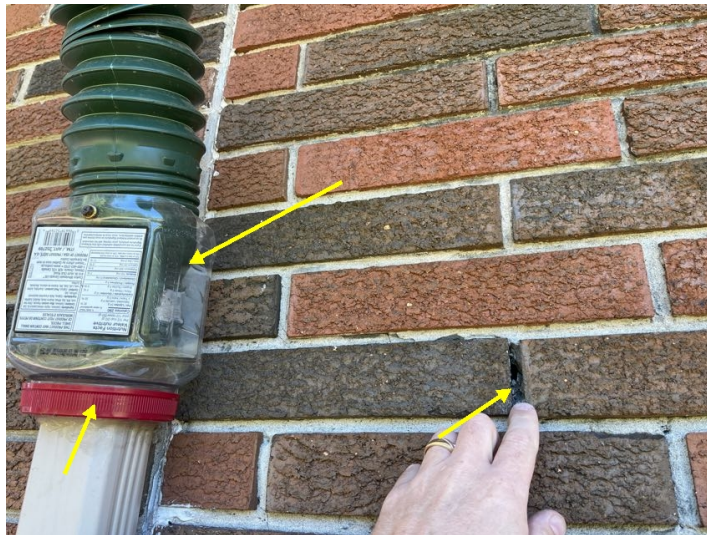
Any openings in the brick work should be re-mortared.

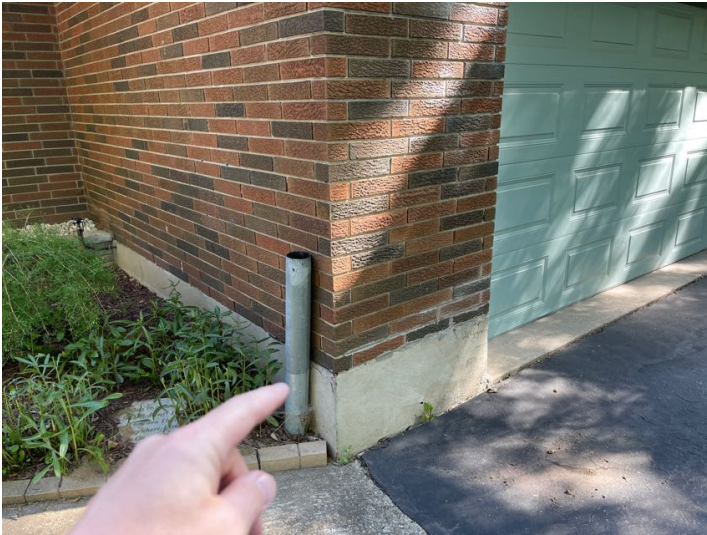
This is a unused hook up for draining the gutters underground. The gutters are now draining out onto the ground as they should be. There are a few of these abandon underground hook ups, which should be cut off and capped.

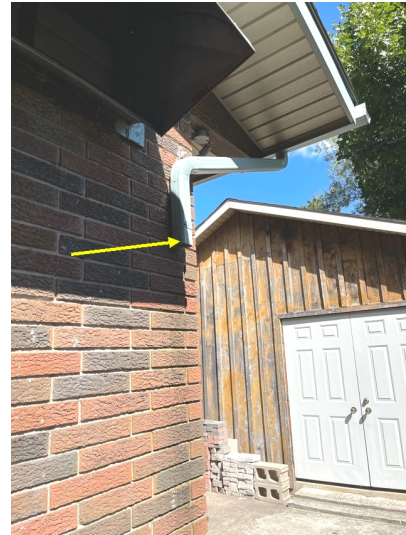
Rear right of the home. Recommend extending this downspout so that there is not water dumping it next to the foundation.

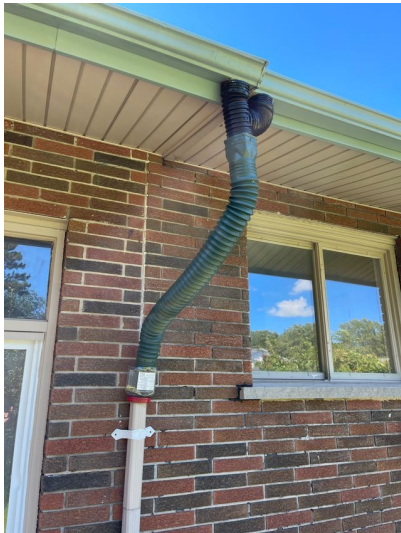
This is an unreliable connection. These accordion style extenders, crack, and break with sunlight. This gutter is also draining into an underground connection. Recommend having a proper downspout installed and discharged out on to the grass.

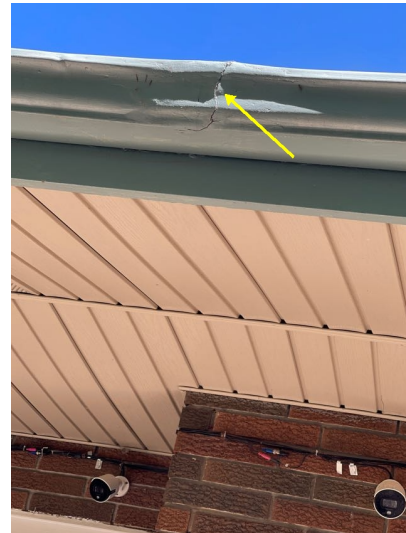
This section of gutter near the front door is damaged. Recommend splicing in a new piece or replacing the entire gutter.

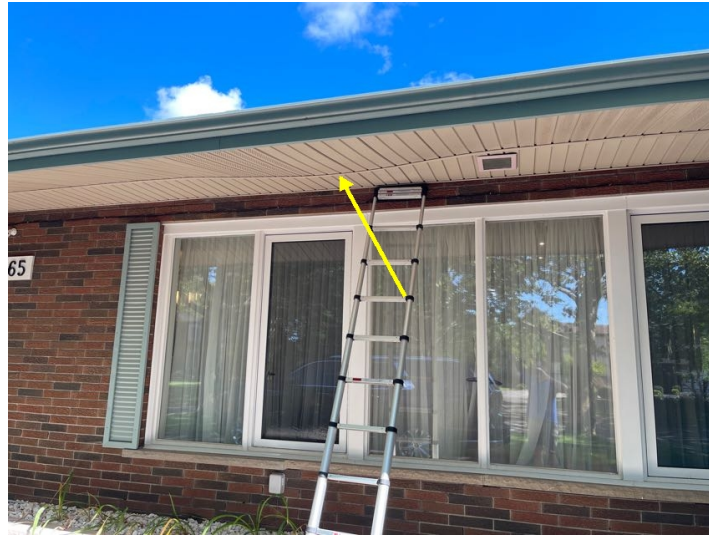
The soffit material has come loose in the section recommend reattaching soffit.

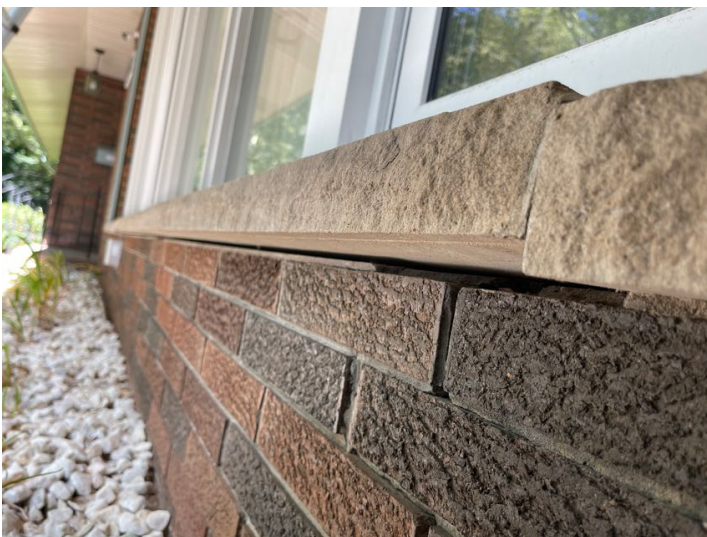
The windowsills at the front of the home are slanted towards the windows. This encourages water to flow behind the brickwork and may cause damage to the wood framing behind. Recommend removal and reinstallation of the windowsills at the front living room windows.

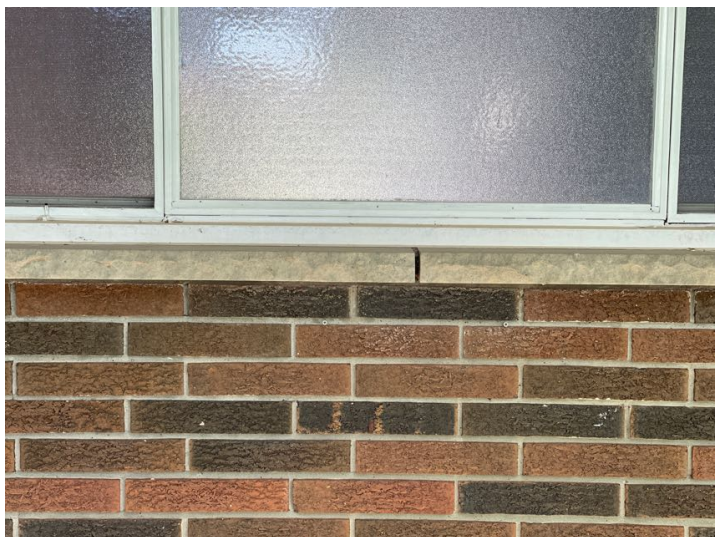
Missing mortar between two windowsills at the front of the home. Pool room. Recommend repair to avoid water infiltration behind the brick work. The other window has martyr however, it is deteriorated and needs to be replaced as well.

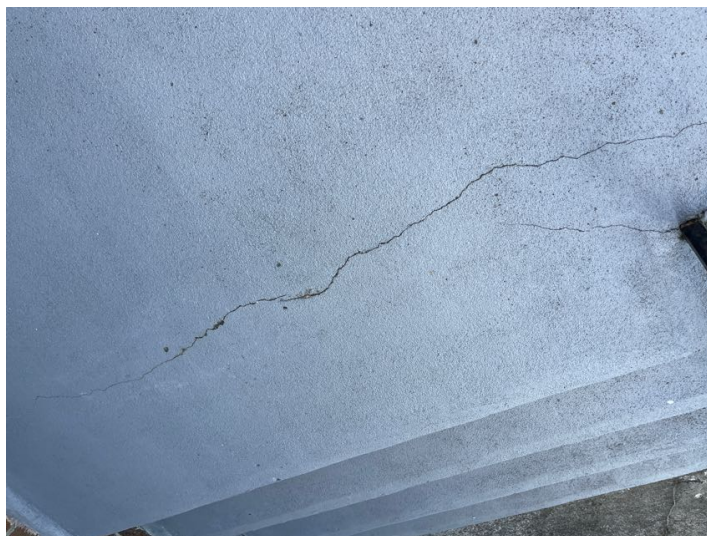
Recommend ceiling is crack. If it is not sealed, water will get in and freeze and make the damage much worse every year. You could use a polyurethane caulking after the crack is notched out.

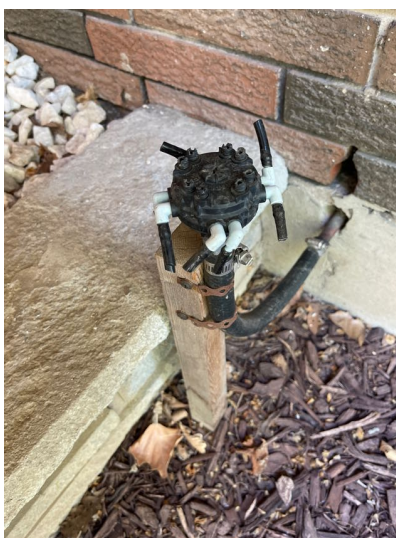
Sprinkler head at the front of the home at the corner where the pool building starts. The sprinkler head seems to have a bunch of lines cut. Sprinkler systems are not included as part of the home inspection. Recommend sprinkler company evaluate the system if the system is not shut down properly in the winter there can be damage.

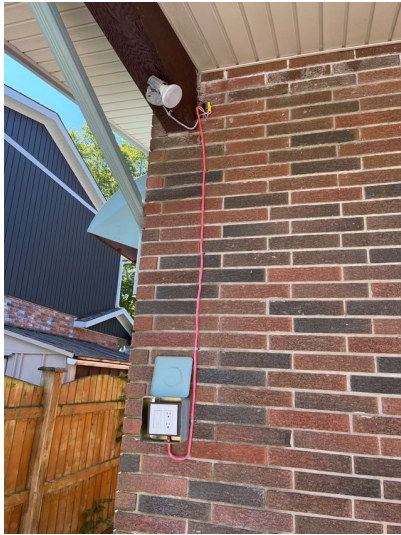
This connection located at the right rear corner of the home. At the time of inspection, there is no power to the light or the receptacle. There is indoor wire being used outside, which is not proper because it is not designed to stand the sunlight. There are exposed connections at the top, which is incorrect. Recommend electrician to reinstall.

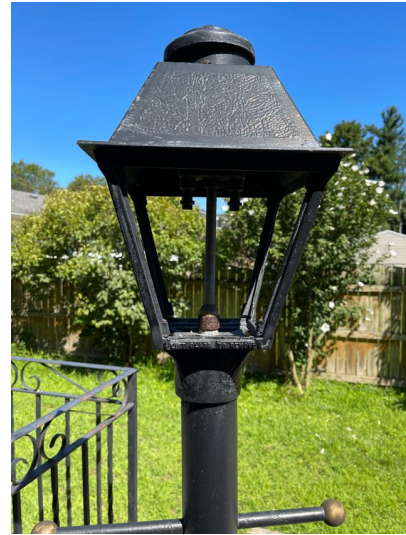
This is a natural gas light. It was not functional at the time of inspection.

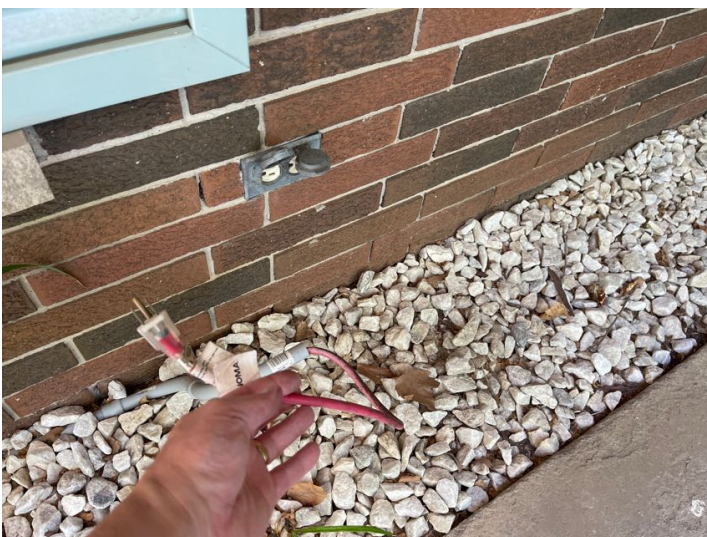
This extension cord powers, the GFCI receptacle that is near the front door. It is not a typical installation, but there is nothing wrong with it. The electrical outlets on the exterior should all be upgraded to GFCI.

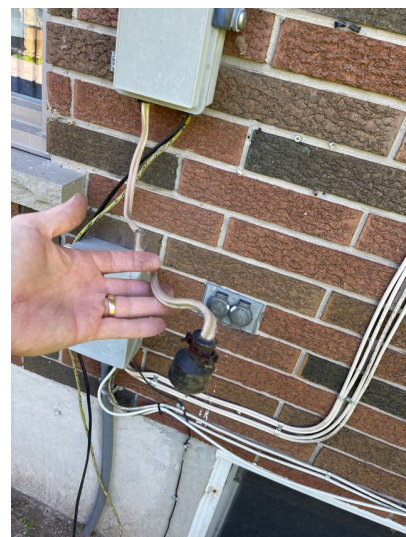
Non-exterior rated electrical wiring in use. Recommend electrician replace.

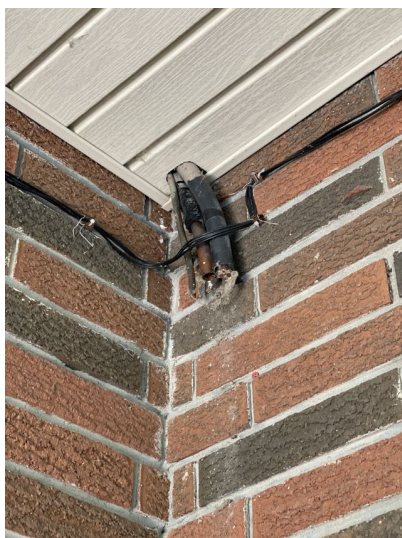
Front of the building. This is an old HVAC air conditioning hook up. This is of no concern and can be removed if you wish. The line was checked at the time of inspection, and there was no electrical power at the line which is the way it should be.

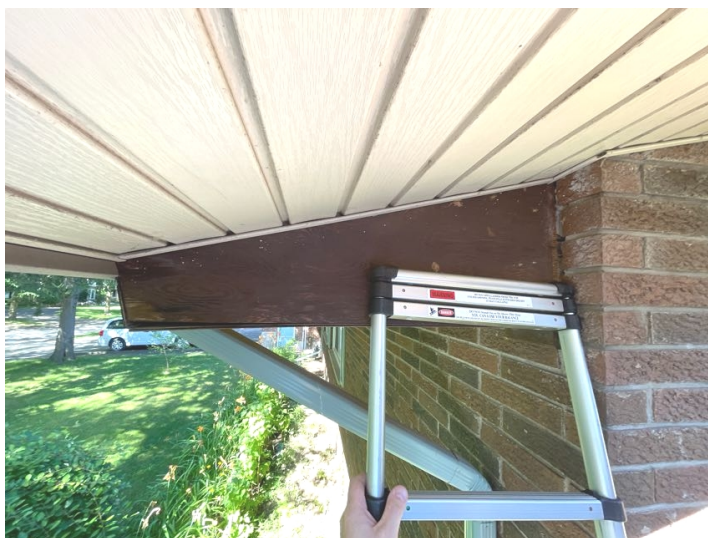
Front right corner of the home. These cantilevered roof joists are covered with a stained plywood to protect them from rot. This one on the end is open on the lower edge and should be repaired. The area where the wood covering meets the home has a gap which allows water to enter and damage the wood. At the time of inspection, the wood was probed at this location and found to be in solid condition. Recommend ceiling this area with a polyurethane caulking see picture A for close-up

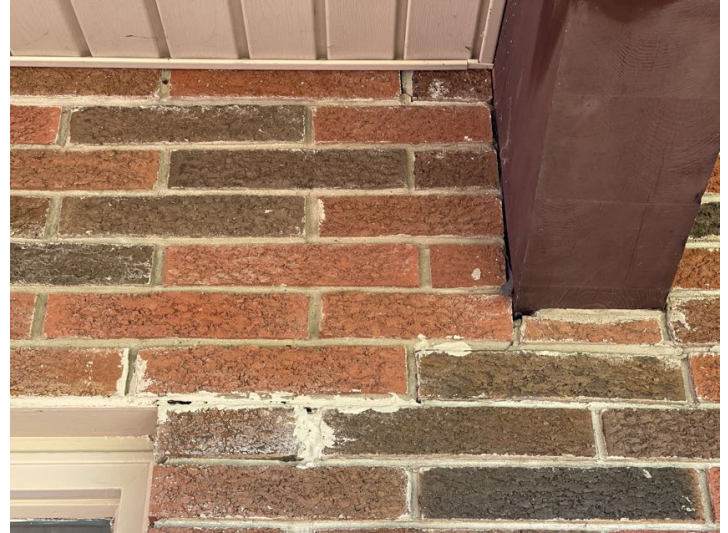
At the back of the home, several of these cantilever joists have gaps at the sides. Recommend sealing the sides of the polyurethane caulking. I would not seal the bottom portion, so that water can escape in the event that it was to get into the area.

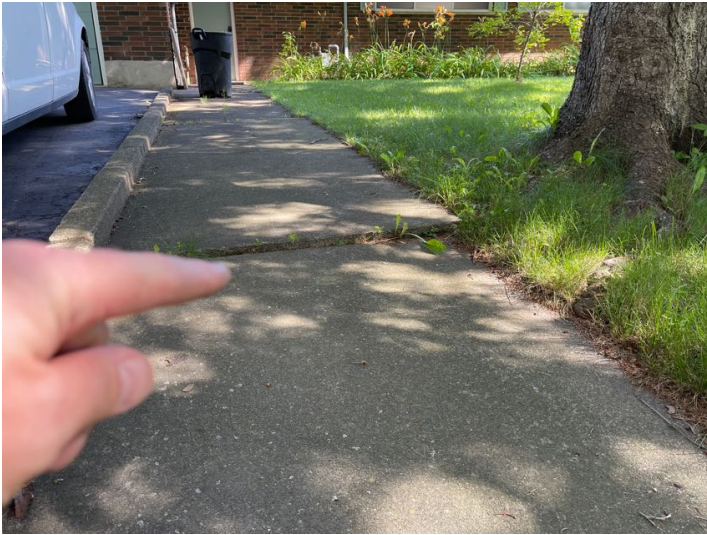
The walkway to the right of the driveway. This walkway is a trip hazard because part of the walkway has sunk while others have risen. Recommend repair.

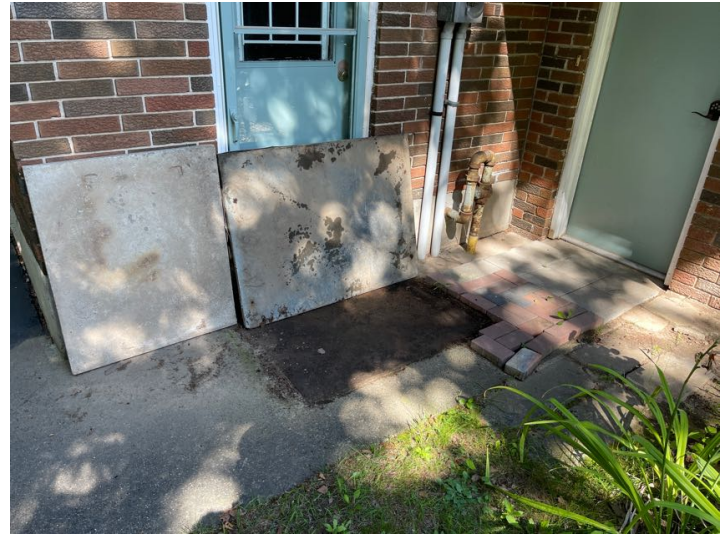
This piece of metal as well as the bricks in this area are not necessary.

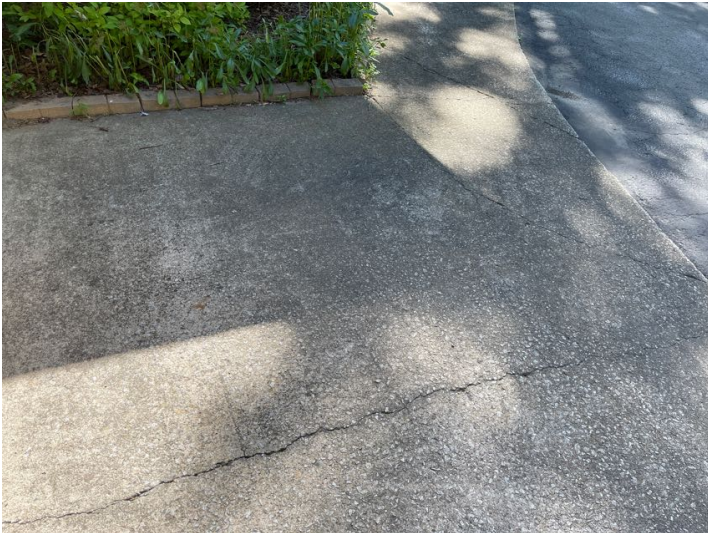
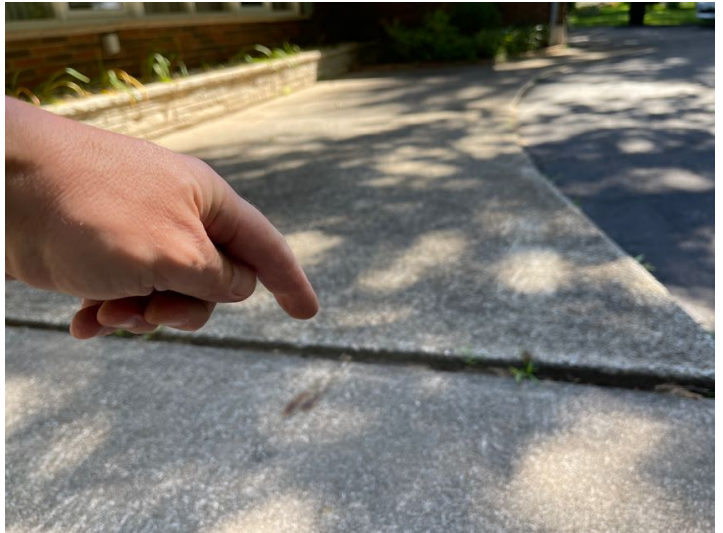
The front walkway at the front of the home is cracked in several areas. Recommend sealing the cracks with the polyurethane caulking.

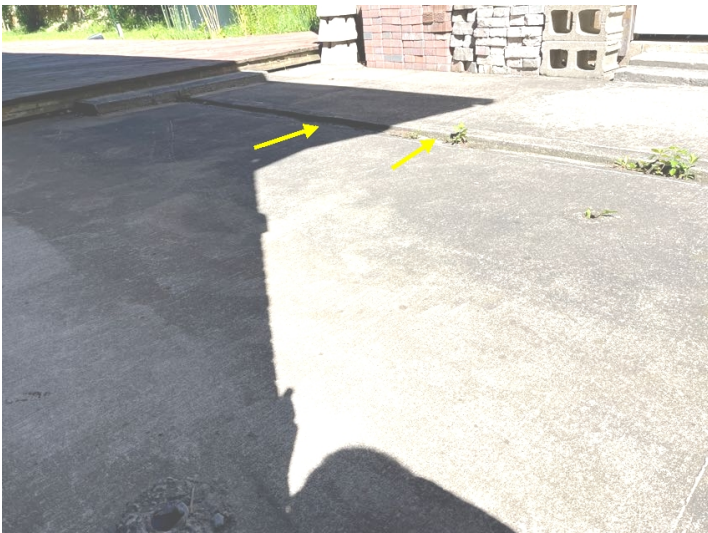
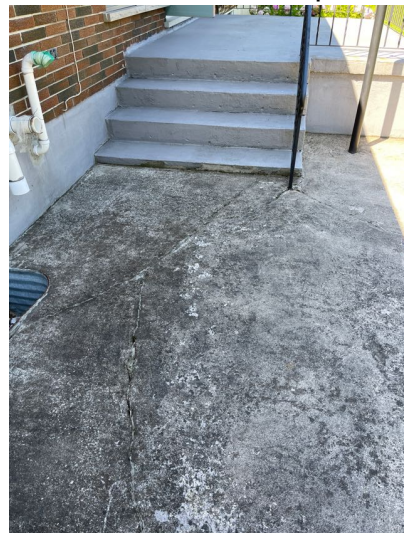
This is the concrete deck at the back of the home. This is a trip hazard in this area use caution.

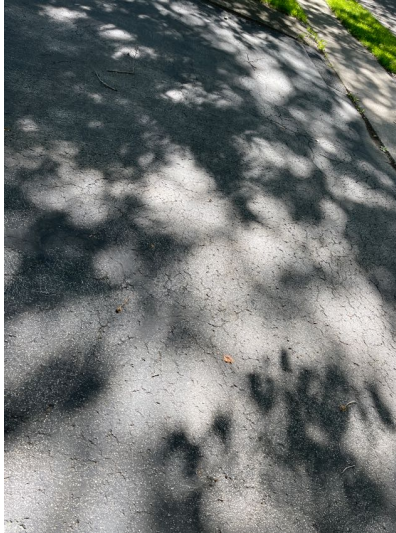
- Settled asphalt in some areas.
- Recommend driveway sealing to extend the life of the driveway.

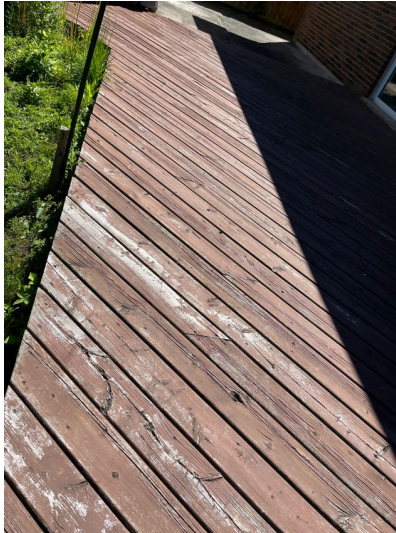
• **Recommended sealing deck to extend life.**

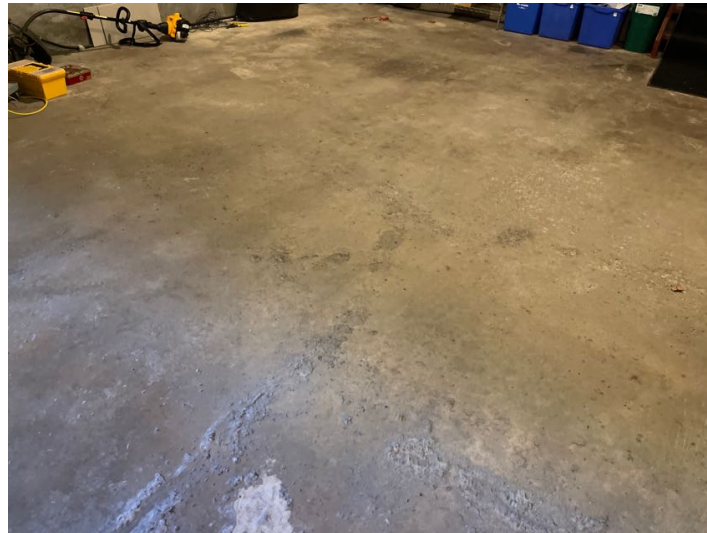
There are some common cracks in some spalling concrete in the garage

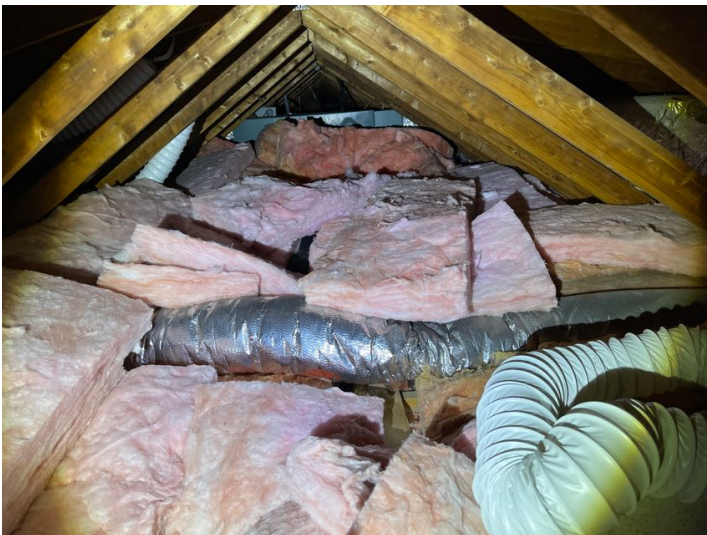
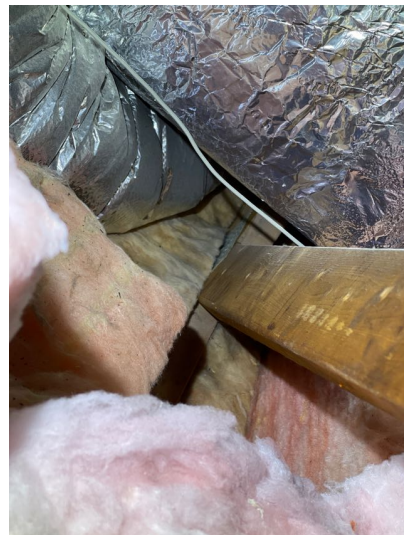
Materials: Fiberglass
 Depth: 2- 12 inches
 Insulation levels are sporadic and varied throughout the attic. Full inspection of the attic was not possible is there is an air handler in the centre of the attic restricting space.
 Observations:
 • **Recommend further review and upgrades by a qualified insulation contractor.**

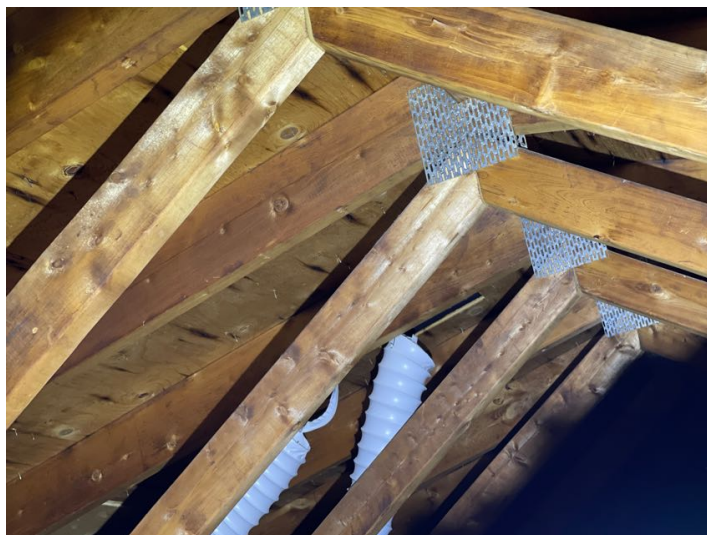
Bathroom exhaust are near the roof vent. However, they should be vented properly as this can still allow moist air condensation in the attic

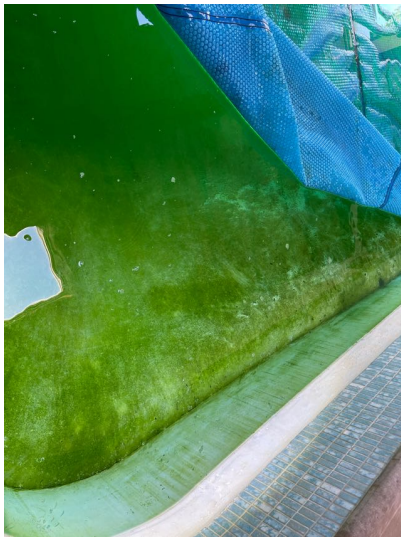
The pool was not in operation at the time of inspection. The water level was below. The Jets therefore testing of the pump filter and heater is not possible. This is a concrete pool. There is heavy, algae staining of the pool.

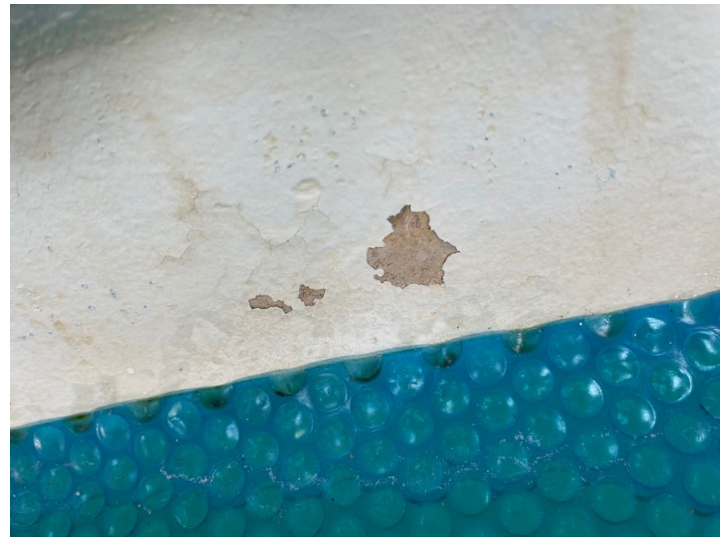
The pool paint is starting to come off in sections. Keep in mind that my view was restricted by algae and a solar blanket that I lift it and moved around to look underneath. In my opinion, you will need to get this pool refinished.

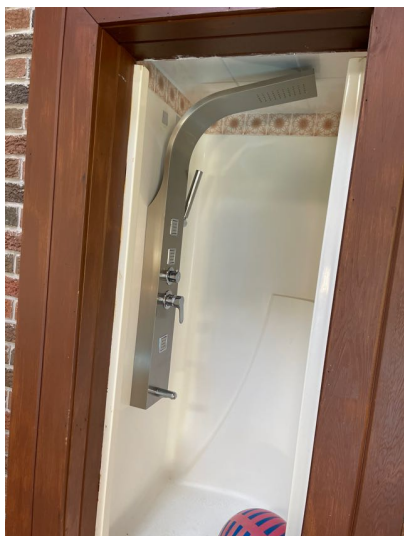
There is no water onto the shower at the time of inspection. Recommend current owner demonstrate that it works. As home inspectors we do not turn gate valves on that have been turned off because they so frequently leak and caused damage.

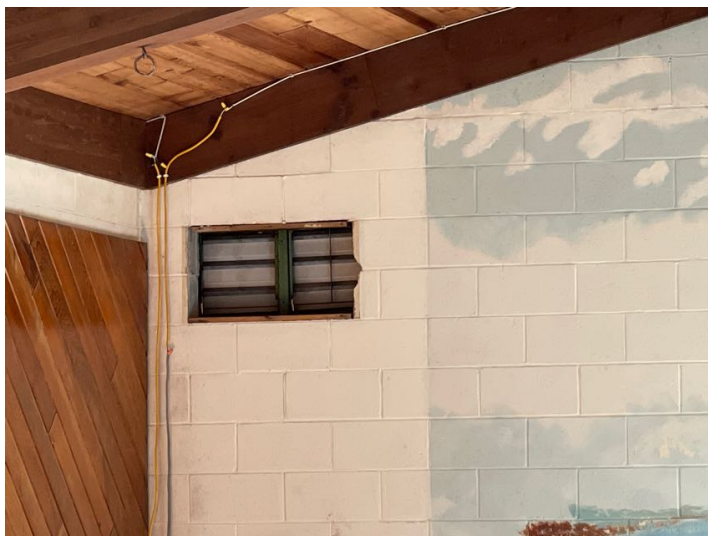
At some point in the past the pool had a ventilation system it appears that it drew air in through the garage and sent it out through the right side of the home as shown here. There is no exhaust system or air handlers hooked up any longer, which is a major problem because excessive humidity leads to mould growth. There appears to be light gray staining on several areas of the wall, suggesting possible, mould formation. Mould sampling was recommend, client declined.

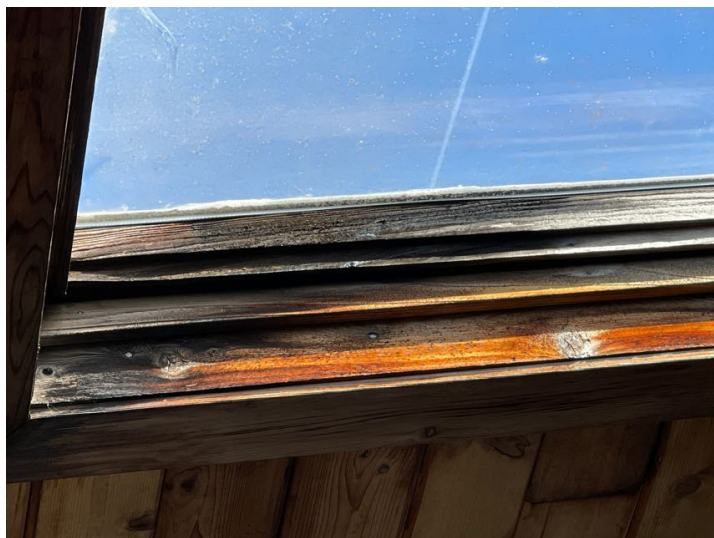
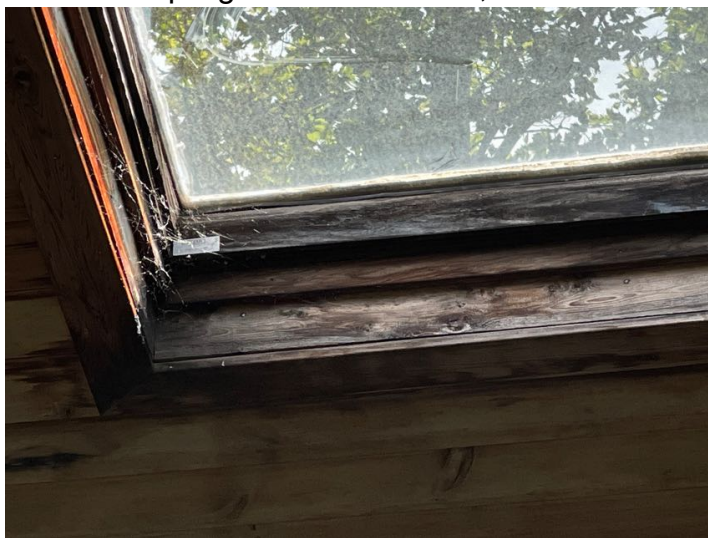
All the wood on the interior section of the skylights is stained black. Recommend testing for mould. Because of the staining, you will most likely need to replace the skylights and the wood around them should the black staining be confirmed mould by a lab.

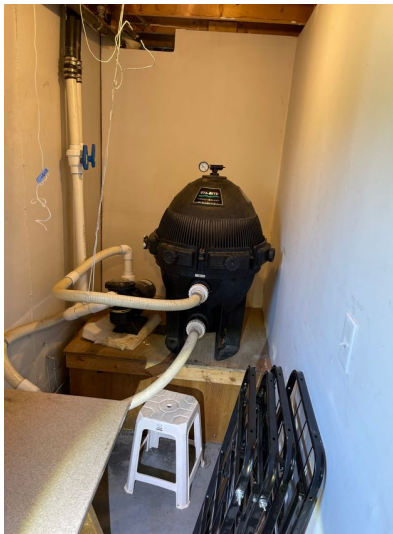
The pool filter and pump are located in the basement furnace room. There is a floor drain on the other side of the wall. However, you may wish to install a drain closer to this area. If there is ever a leak from the pump or the filter, it would be best to ensure that the water has his little to travel as possible before getting out of the rest of the basement.

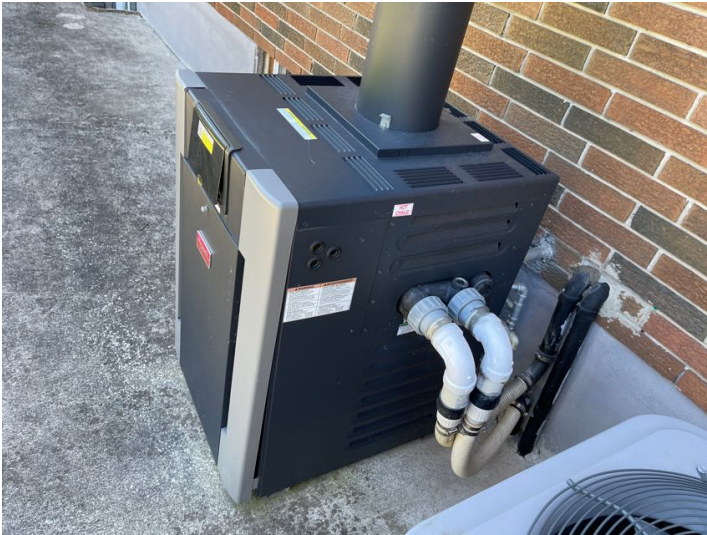
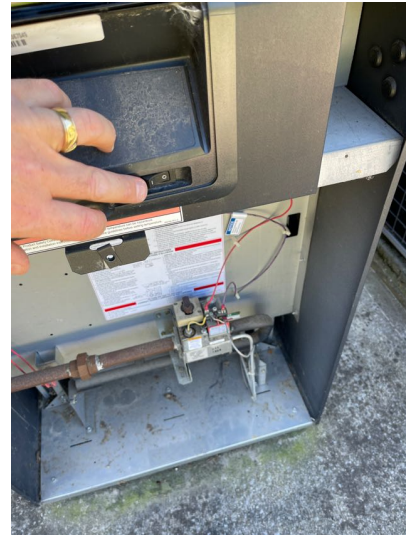
The pool does not have enough water in it to run the pump. I attempted to start the pool heater briefly just to make sure that it is operational. I was able to get the pilot light on however, I was not able to get the main burner to fire. This may be due to spiderwebs inside of the gas lines. This electrical switch that I am pointing to is also jammed and will not turn on. recommend having a pool company, service the heater and clean it.

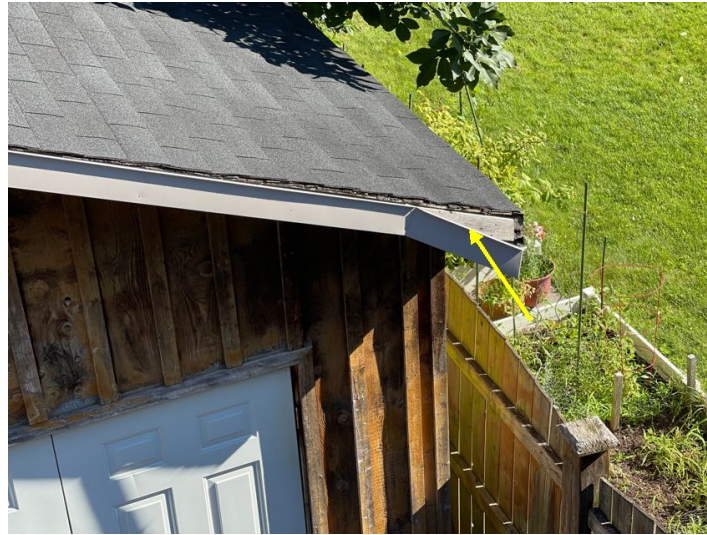
Flashing has come loose. Recommend reattaching to avoid damage to the wood.
