TRUE INSPECTION

Inspection Report

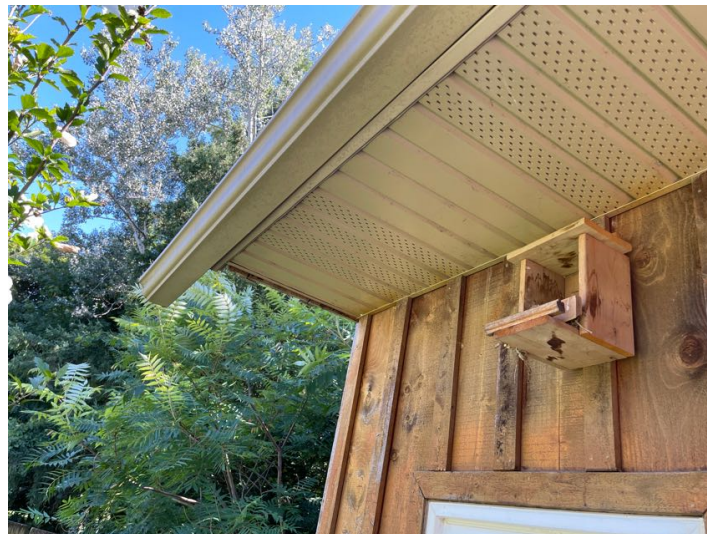
The gutter drains into the neighbours yard. On the right side there is no gutter or downspout. Recommend installing one.

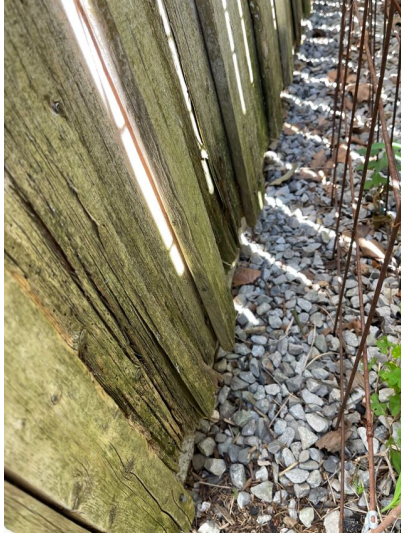
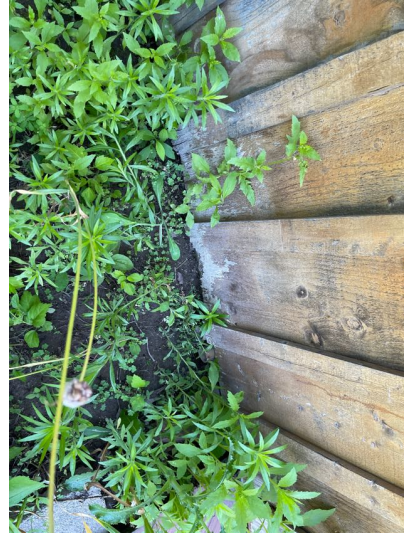
The wood on the lower right section has some rot damage

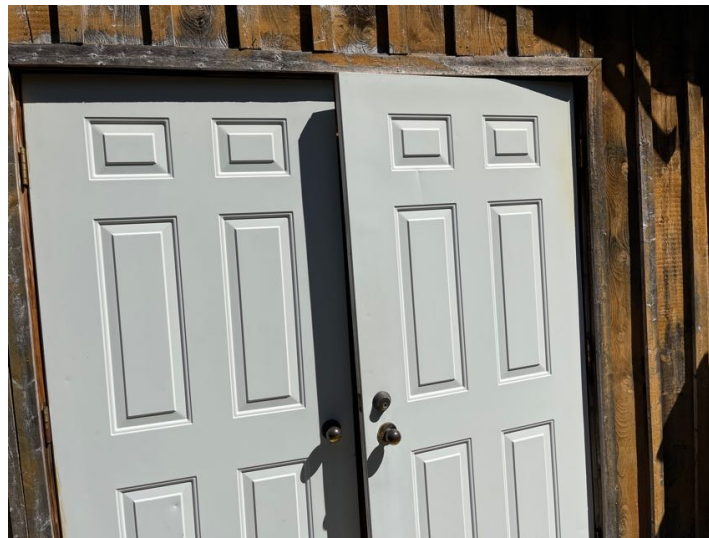
The door hinges are loose and the door does not close properly or easily. Recommend repair.

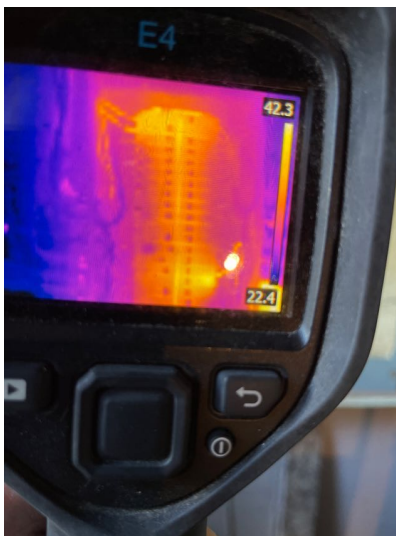
As shown in the picture a few of these breakers are running a little hot. Recommend electrician review.

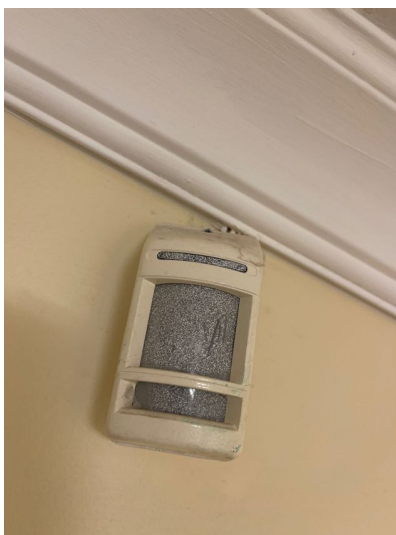
Although security systems are not included as part of the home inspection, I couldn't help but notice that several of these motion sensors have paint over the sensor area. Recommend consulting with your alarm company to ensure these are working correctly.

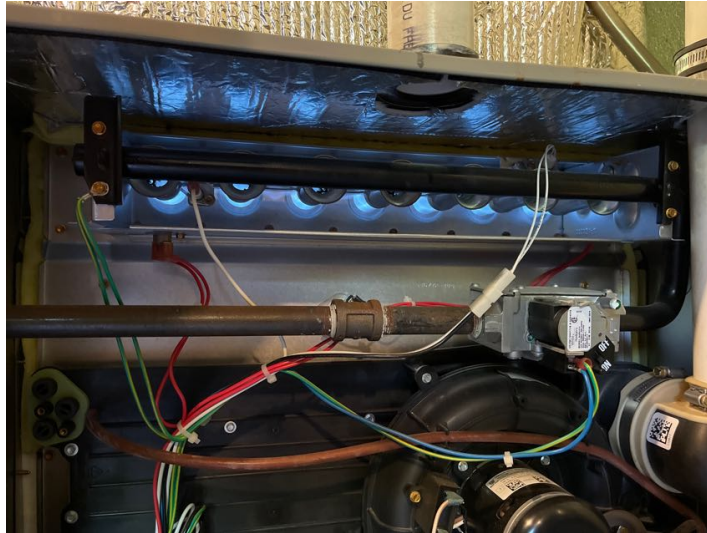
- Good flame color and pattern noted

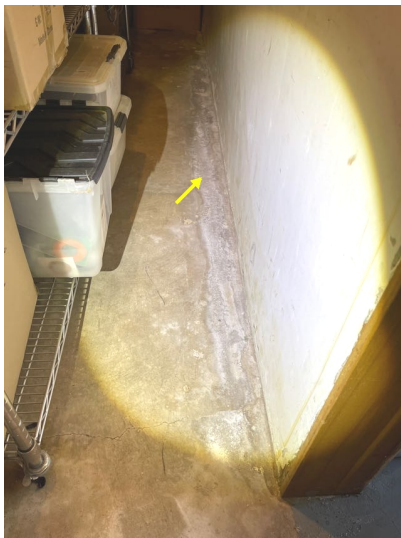
Some efflorescence on the floor in the cold room, which is located closer to the front of the home in front of the laundry room. Efflorescence indicates moisture issues. See picture F.

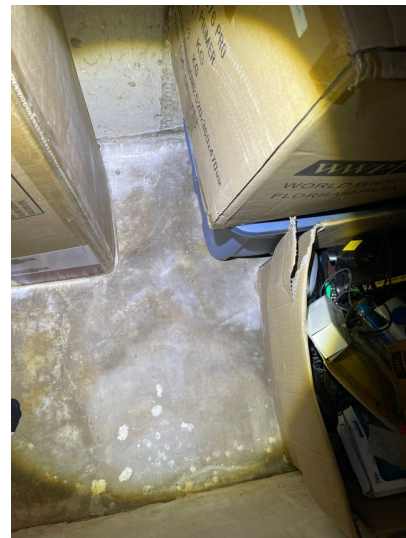
F Here we can see more efflorescence on both the right and left side.

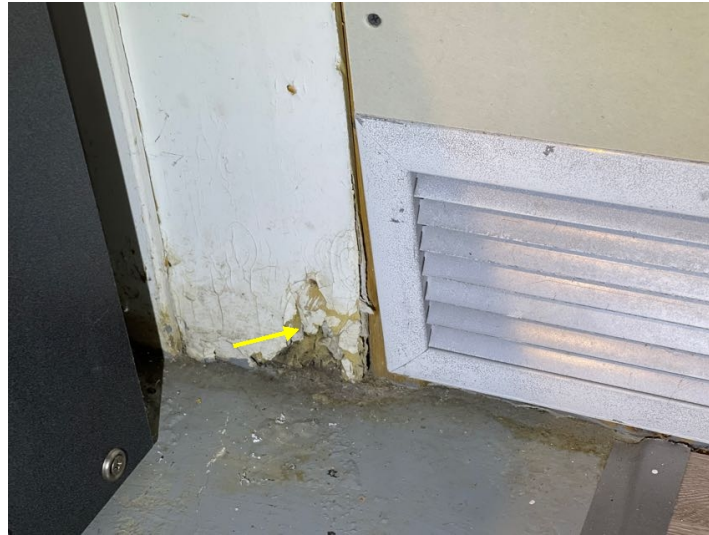
G next to the laundry room entrance door

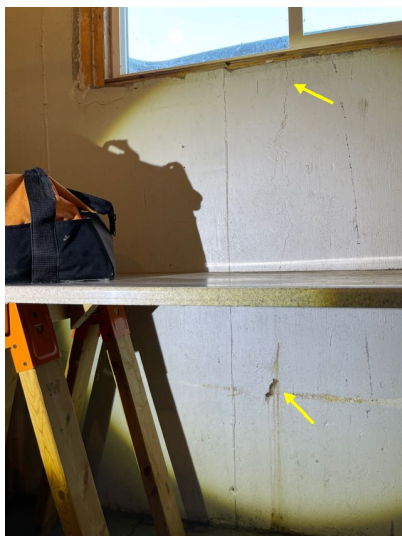
There is a crack in the foundation below the basement window. Looking at the lower part of the picture, we can see staining indicating that this crack has leaked before. Recommend crack injection to repair a crack in avoid future leaks.

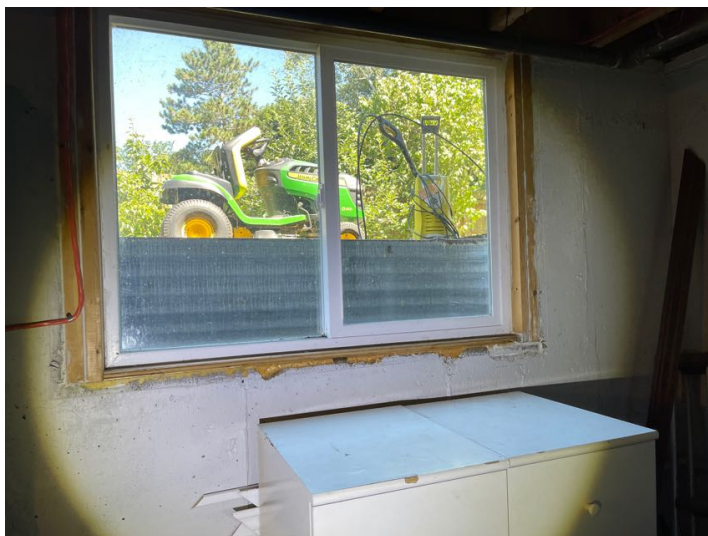
This basement window located to the right of the dryer, has a crack diagonally on the right side of the window. This is an extremely fine crack and not likely to leak, but not impossible to leak. You may wish to have this crack injected, depending if you are comfortable with the risk of leaving it or not. See picture D for close-up

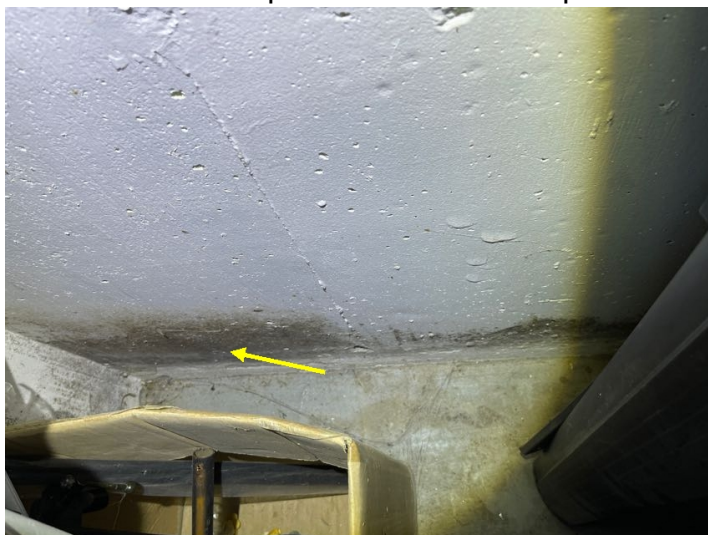
Possible organic growth on this wall, right side of the home, right of the laundry room window labelled D. Recommend cleaning with one part bleach to three parts water.

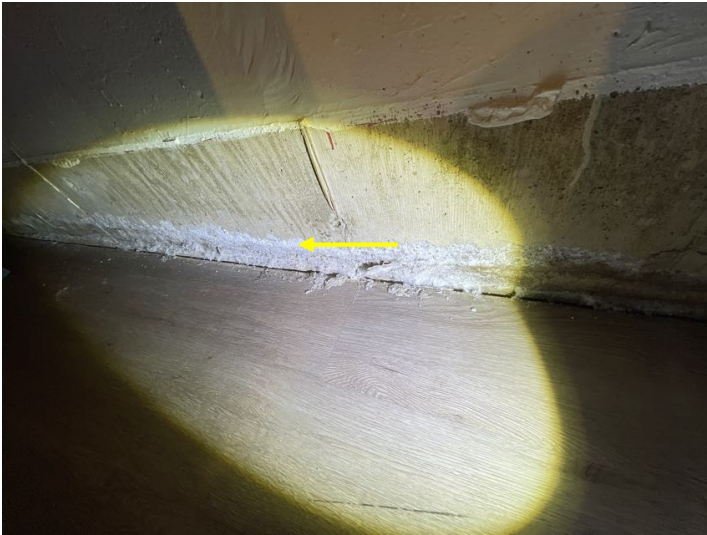
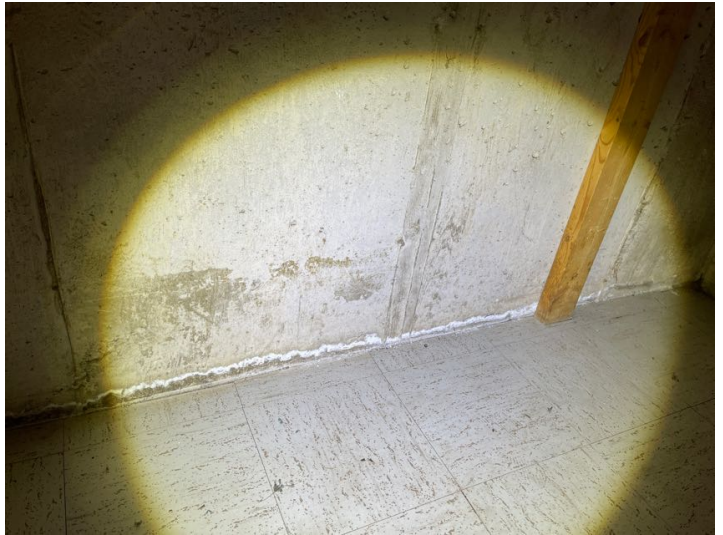
This picture shows efflorescence as well as a white crystal material, which could be a type of organic growth. Recommend testing to determine whether there is any organic growth or not. This is a solid concrete wall. It has a skim coat of plaster, except for on the very lower section. This is the room located on the other side of the chimney clean out

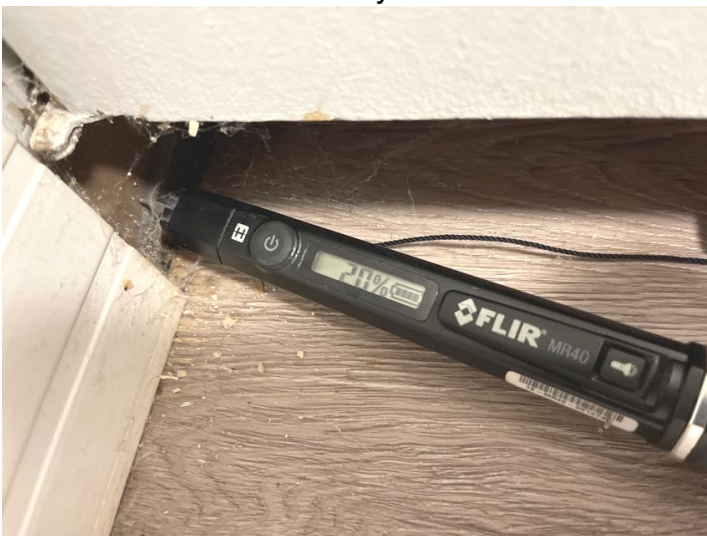
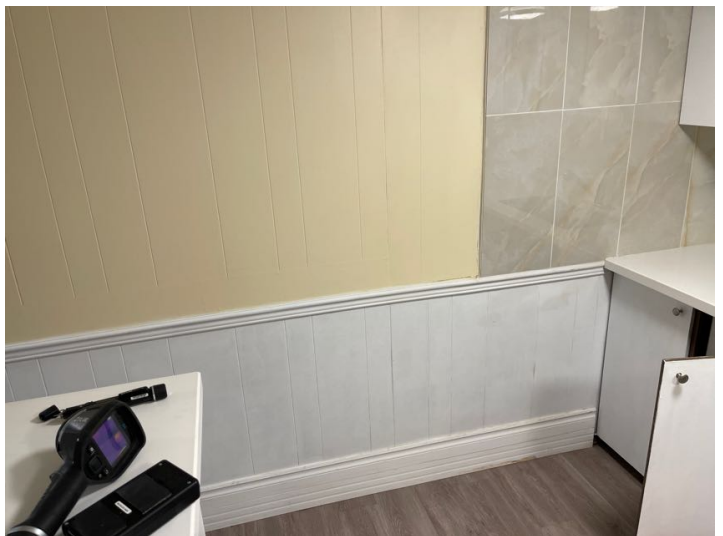
High moisture levels in this exterior wall in the basement kitchen. See picture M

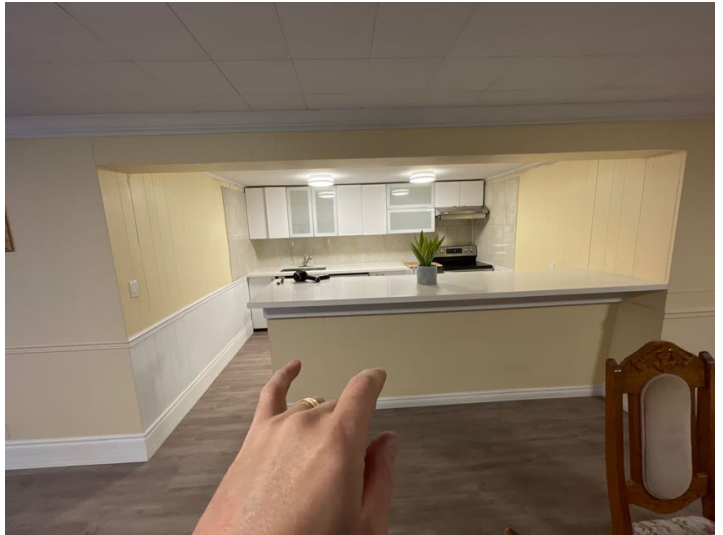
Both of these walls on the right and left side of the kitchen show very high moisture levels when compared to other areas of the basement. We can also see possible organic growth and water damage on the wall paneling. These walls are constructed on the outside of bricks. This kitchen is underneath the back concrete patio. There is also elevated moisture level in the ceiling, recommend foundation contractor review and repair. There is a high probability of mould behind these walls because of the increased moisture level. The back wall of the kitchen is covered with tiles on the back wall which my tools will not detect moisture accurately through.

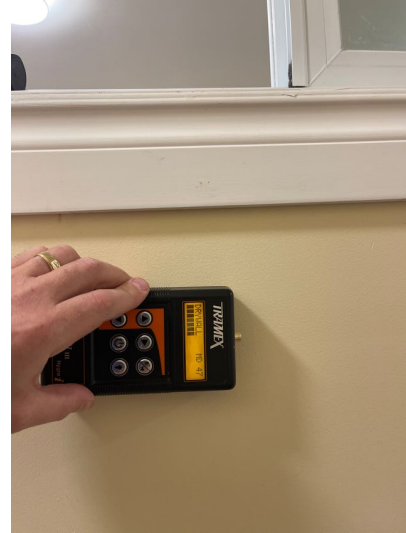
This picture is taken on a centre wall, interior wall of the basement bedroom to show a baseline of moisture level in the drywall based on the humidity levels in the home.

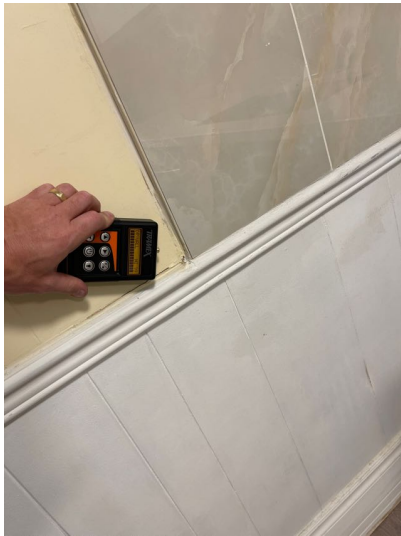
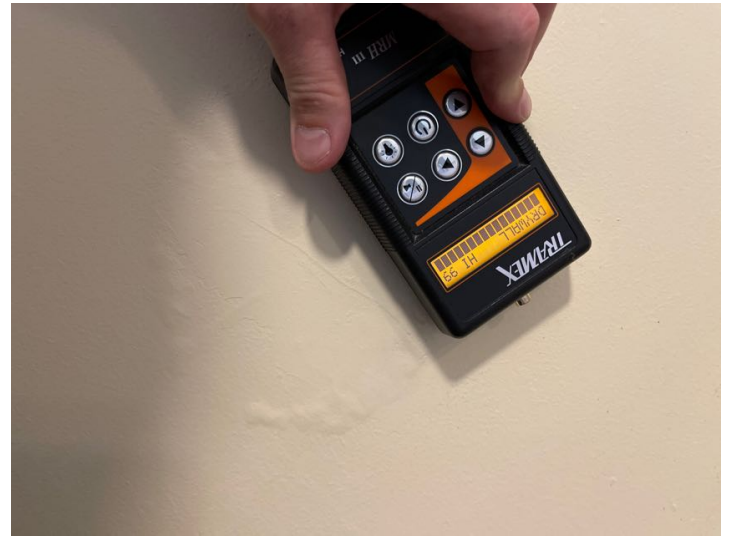
High moisture level and lifted paint in this bedroom indicate there is a leak in the foundation in this section. Basement bedroom rear left side. See picture N

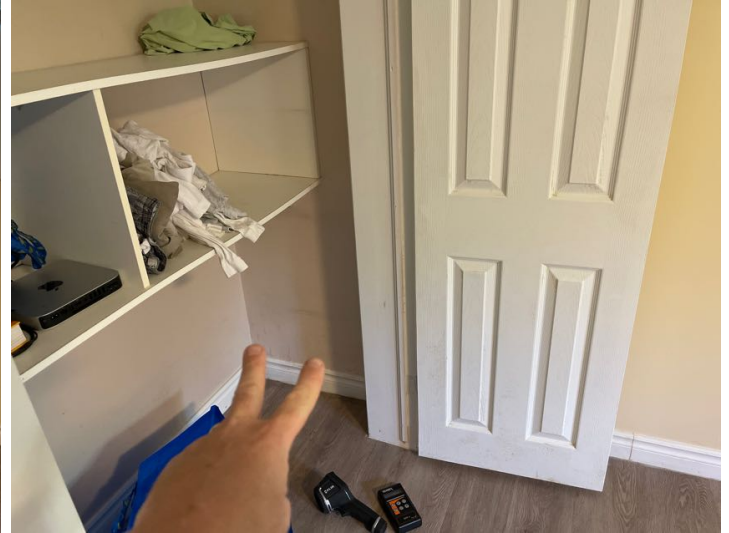
There is also a moisture levels on the exterior wall left side in the basement bedroom closet located at the rear left side of the home. Possible organic growth on this wall aswell.

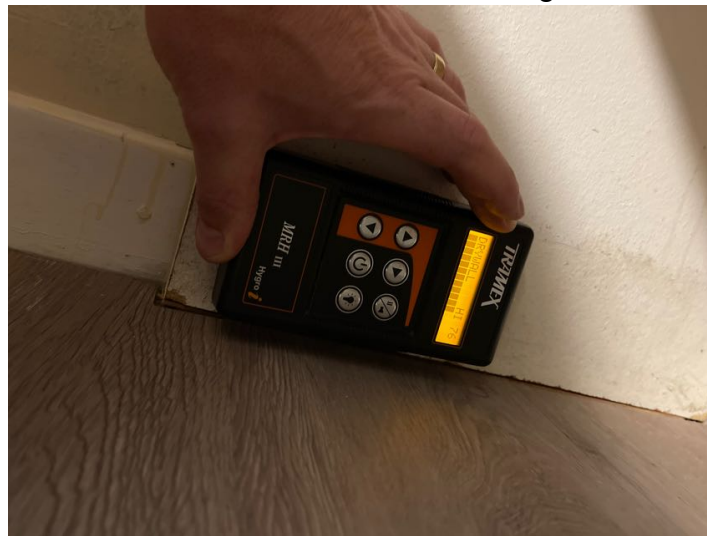
The shelving unit on the lower section in this picture is swollen from water damage. There is discolouration on the baseboard behind it, as well as on the shelving material that resembles organic growth. There is elevated moisture levels in this area, indicating a water infiltration problem.

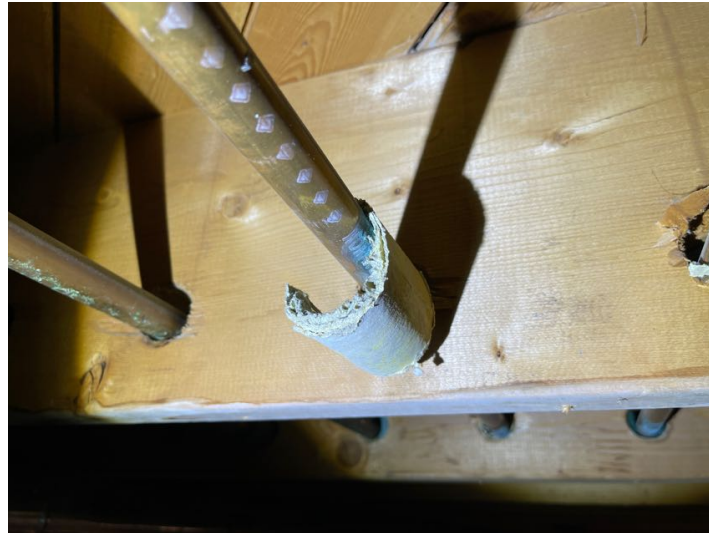
This home previously had a boiler system installed. The copper lines are no longer in use. However, each of the copper lines has a product that is consistent with asbestos. Recommend testing this product. If the product does contain asbestos, it should be removed by a remediation company so that it is not accidentally inhaled. The product is loose in areas and could easily be disturbed even with having a fan running in the room, which means fibers could enter the air.

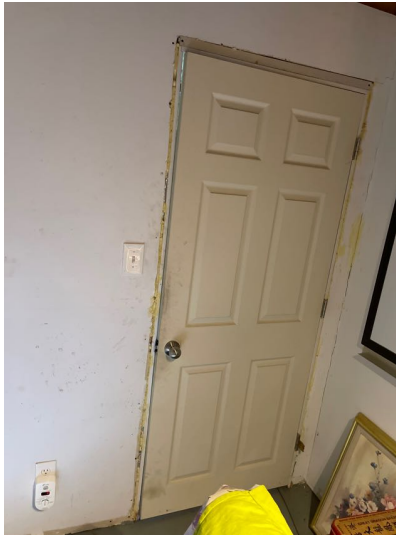
The door going into the furnace room does not close easily. Recommend trimming and reinstalling.

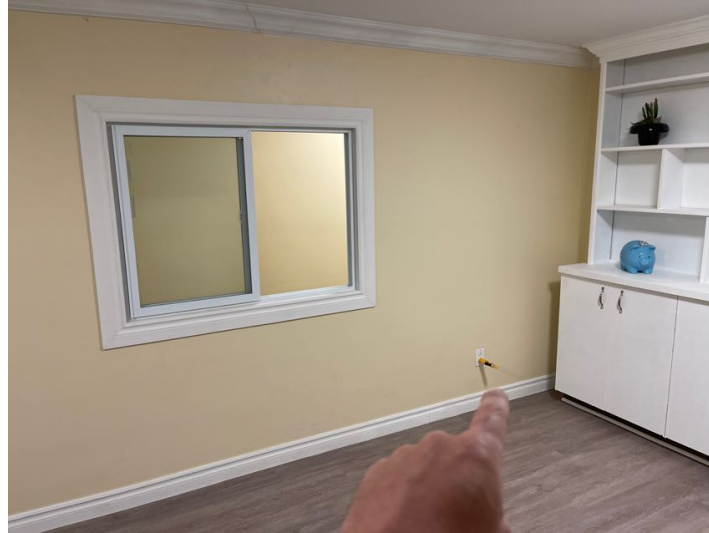
This electrical outlet is wired in reverse. Recommend electrician repair.

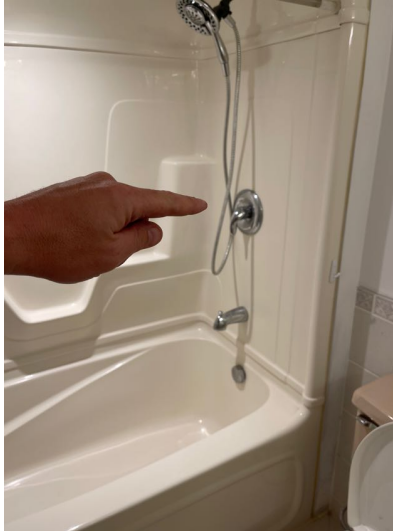
The hot water does not function on this shower. Recommend Plumber repair.

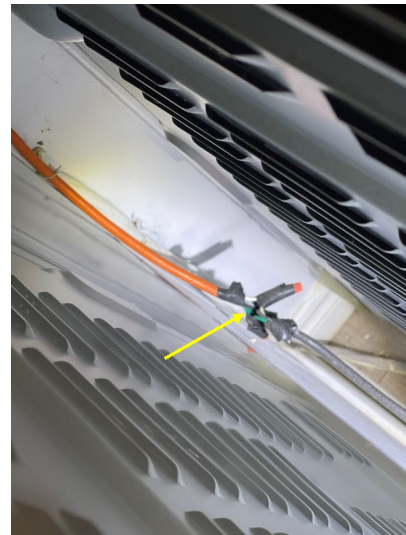
The vent/light over top of the stove is wired in using an extension cord which is hooked up to a power bar. Recommend repair as connections. Should be inside a junction box and not left open as in the picture.

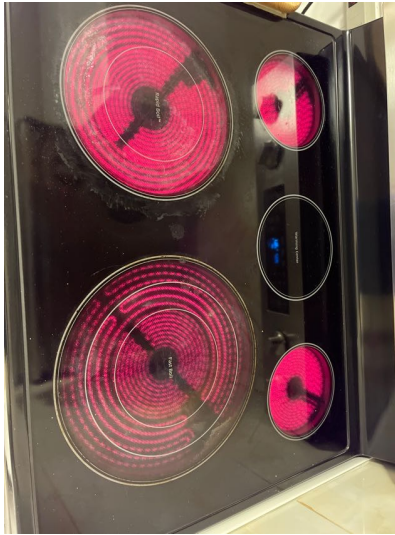
SAT	MRGL	Poor	SI	N/A
<input checked="" type="checkbox"/>	<input type="checkbox"/>	<input type="checkbox"/>	<input type="checkbox"/>	<input type="checkbox"/>

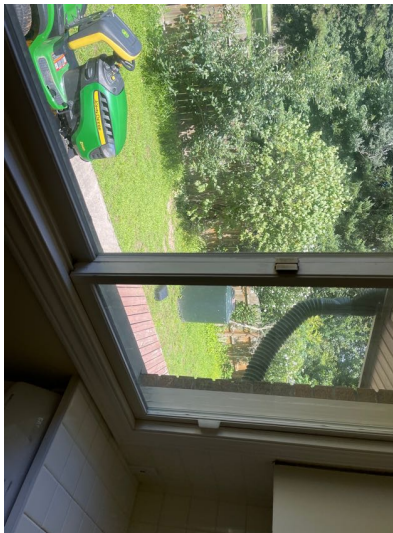
Missing screen on main level laundry room

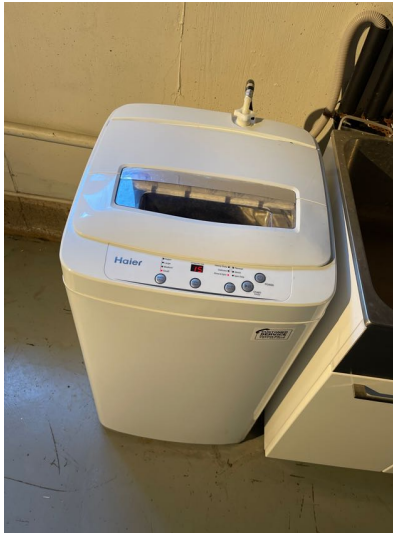
This small washing machine was also tested at the time of inspection it made, no abnormal noises or leaked. These appliances are all rated as marginal because of age.

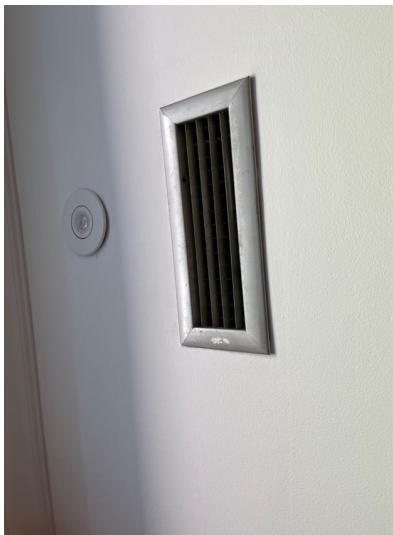
This vent over the kitchen sink does not function. Recommend replacing motor if you wish to use it. The fan over top of the stove functioned well.

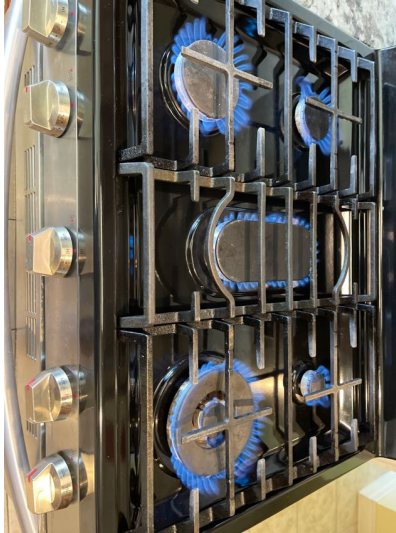
SAT	MRGL	Poor	SI	N/A
<input checked="" type="checkbox"/>	<input type="checkbox"/>	<input type="checkbox"/>	<input type="checkbox"/>	<input type="checkbox"/>

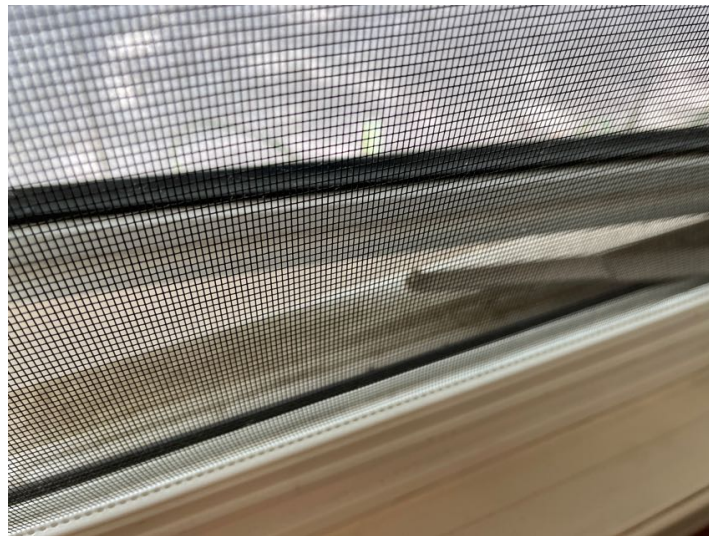
Crank arm disconnected on one of the windows in the front living room.

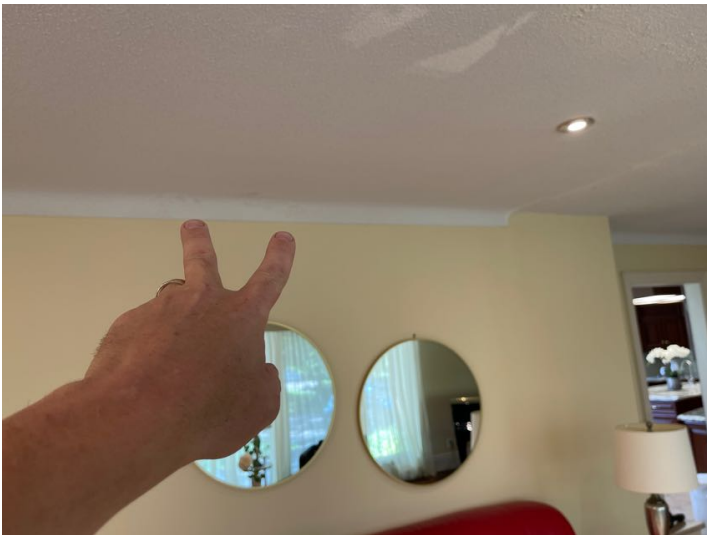
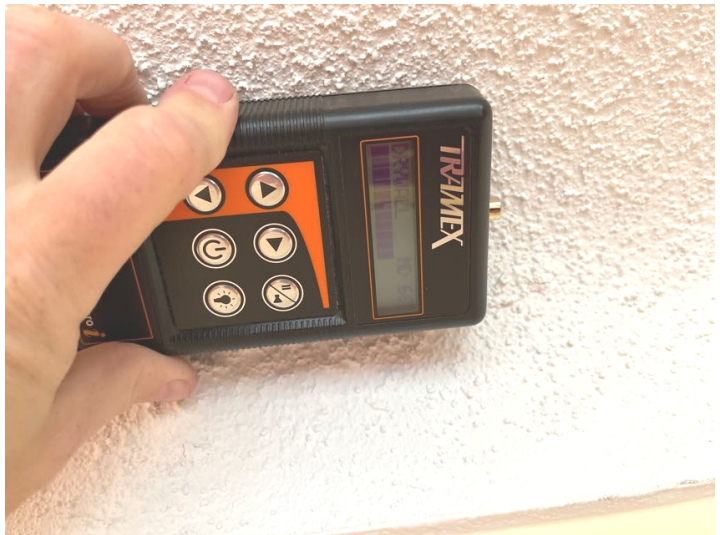
SAT	MRGL	Poor	SI	N/A
	X

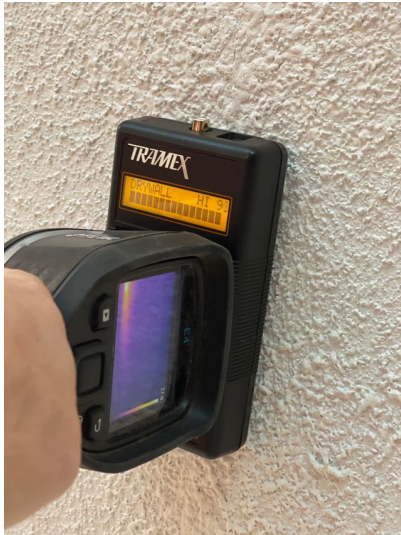
This is a moisture reading of the covered section of the ceiling, where the stucco has come loose

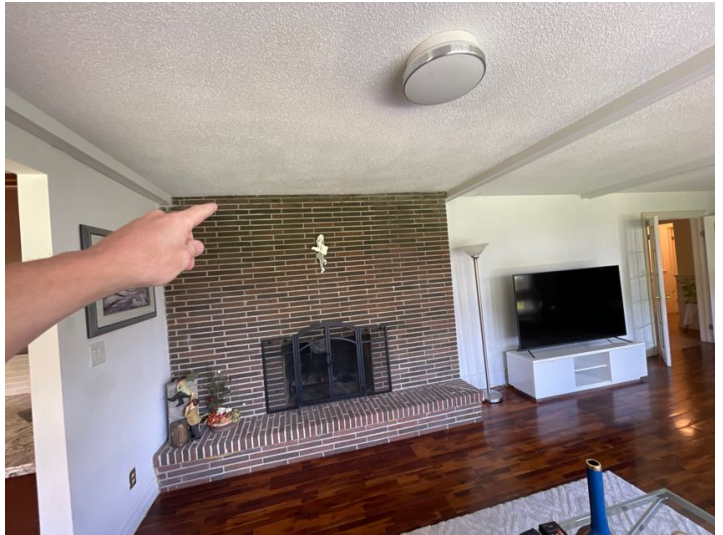
This is the living room at the back of the home. The moisture reading near the brick wall of the fireplace at the top ceiling section is 35 when measuring other sections of the ceiling, the reading ranges from 0 to 8. There is no visible damage in this area however the increased humidity level is most likely caused by the same poor chimney condition.

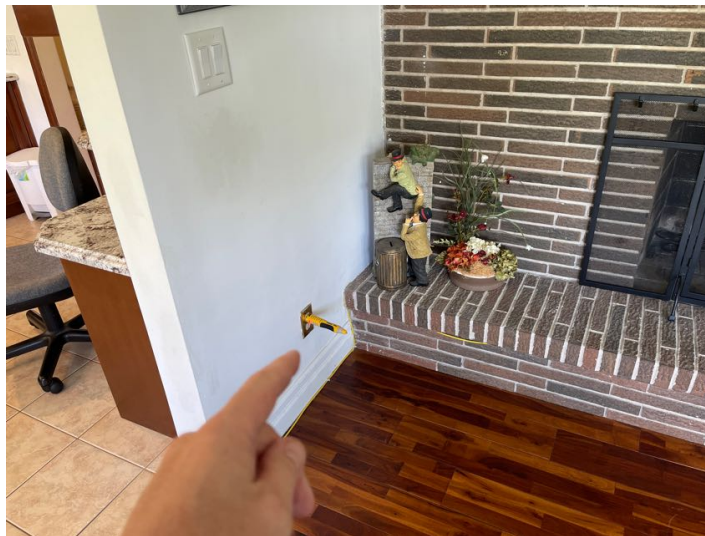
Open neutral. Recommend electrician replace receptacle.

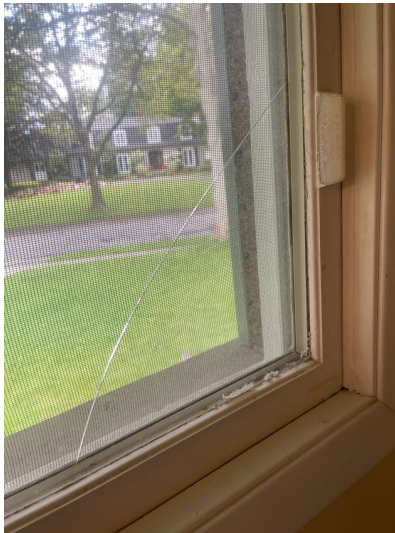
Cracked glass. Bedroom at the front left corner of the home.

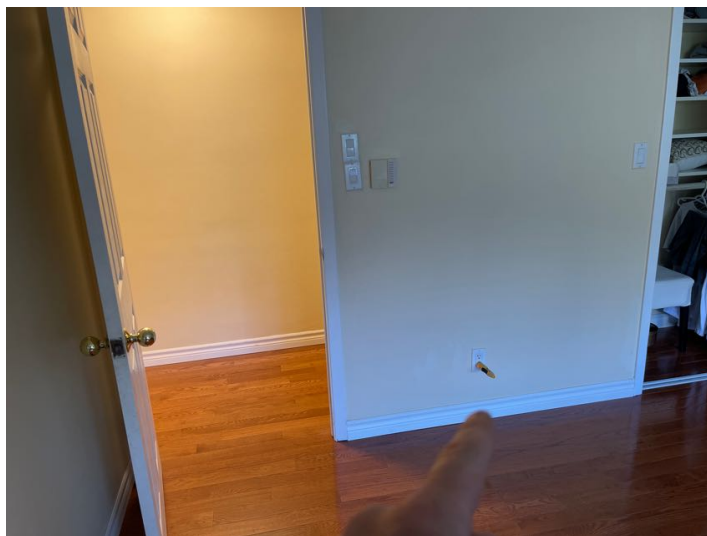
The bedroom at the rear of the house far left side. This outlet is not grounded. Recommend electrician repair.

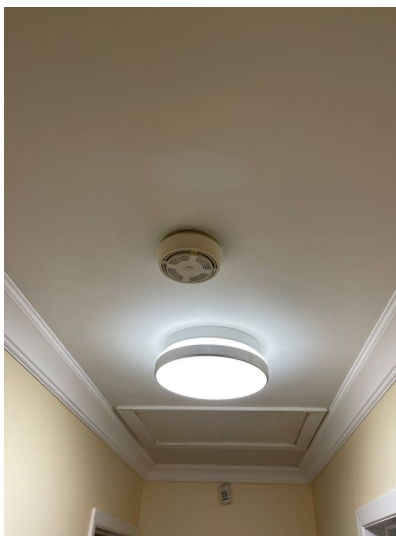
Bathroom attached to Master Bedroom

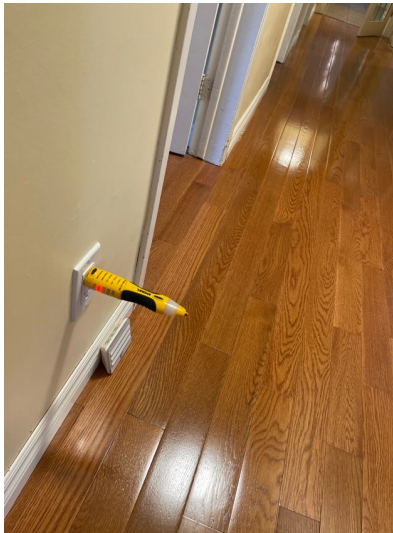
This outlet in the hallway on the main level is ungrounded. Recommend electrician repair.

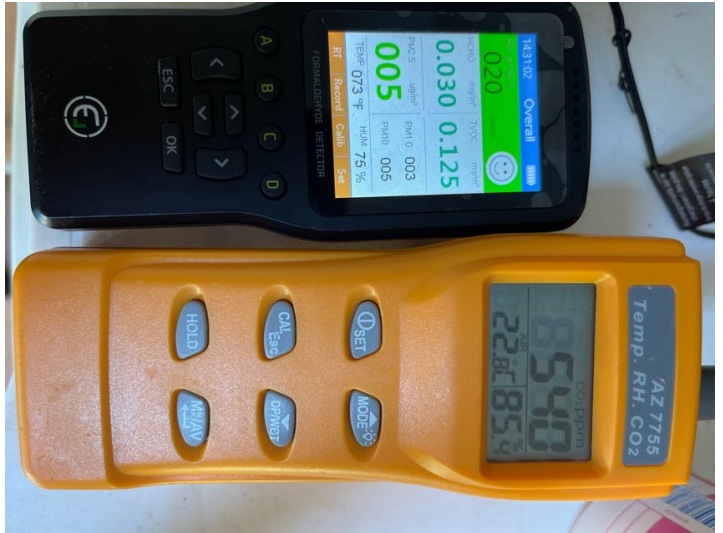
This reading was taken in the pool room. The humidity level is too high.

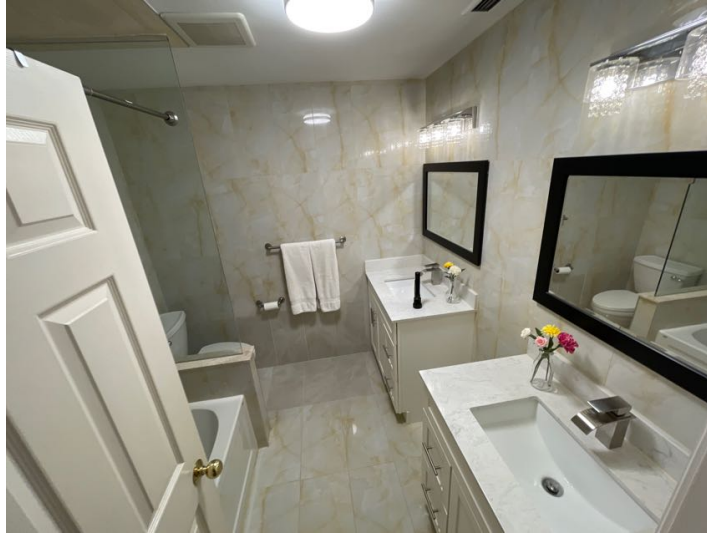
Bathroom located on main level. Main bathroom off of hallway.

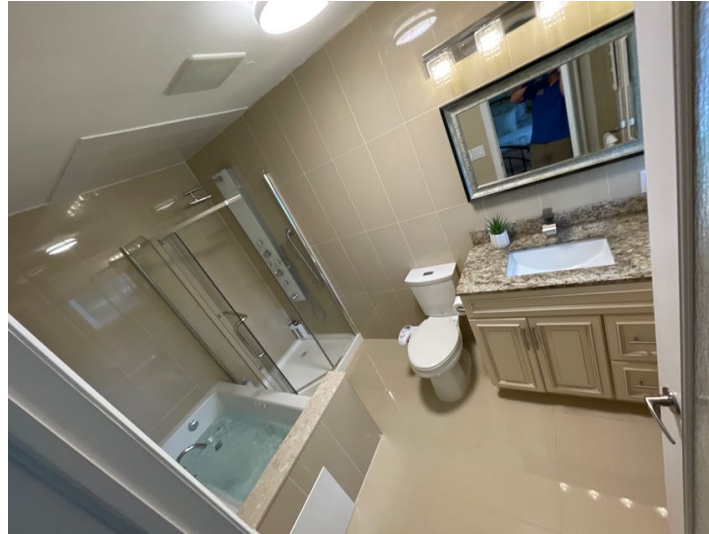
Bathroom attached to the bedroom at the front of the house left side

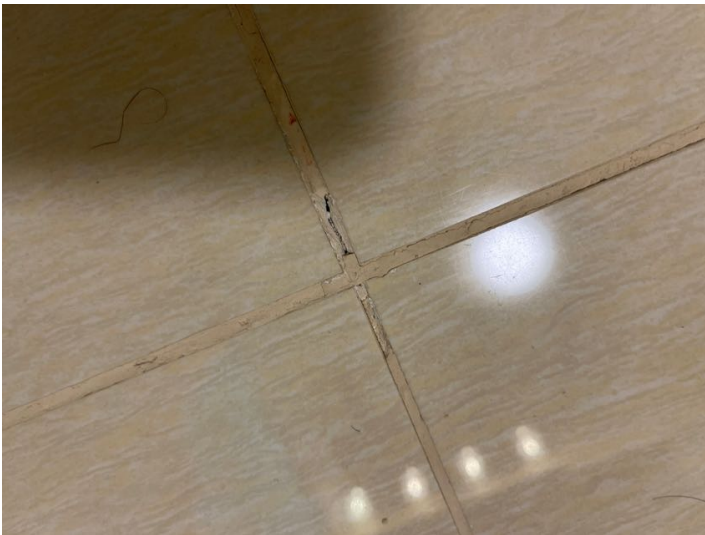
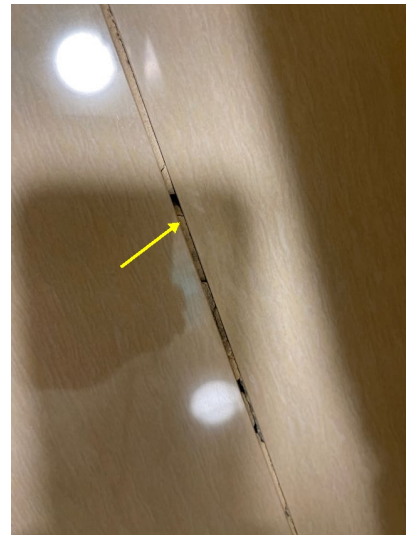
Missing and cracked grout in areas. Recommend re-grouting the floor.

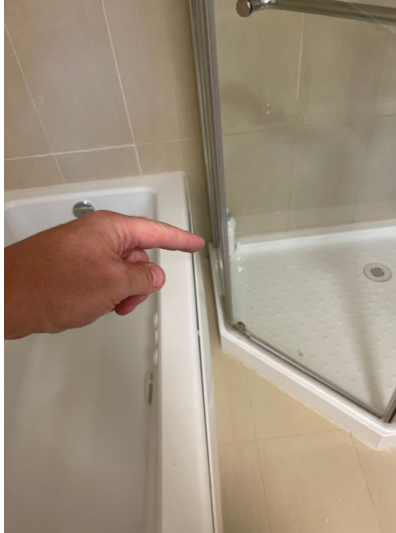
Water leaks from this area when the shower is in use. Recommend resealing this area to avoid water damage on the floor and on the ceiling in the basement.

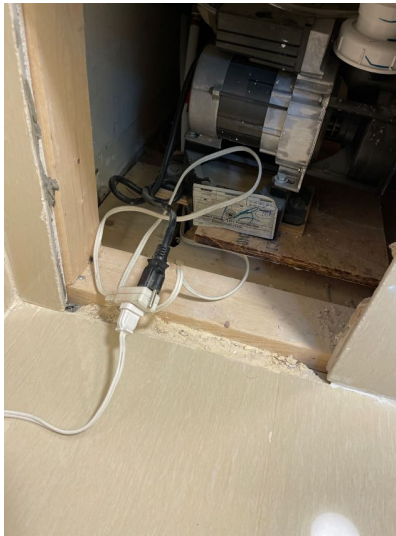
The bathtub motor is being fed by an extension cord that is also powering a TV in the other room. Recommend electrician hook up the pump to a GFCI receptacle. This is a safety issue.

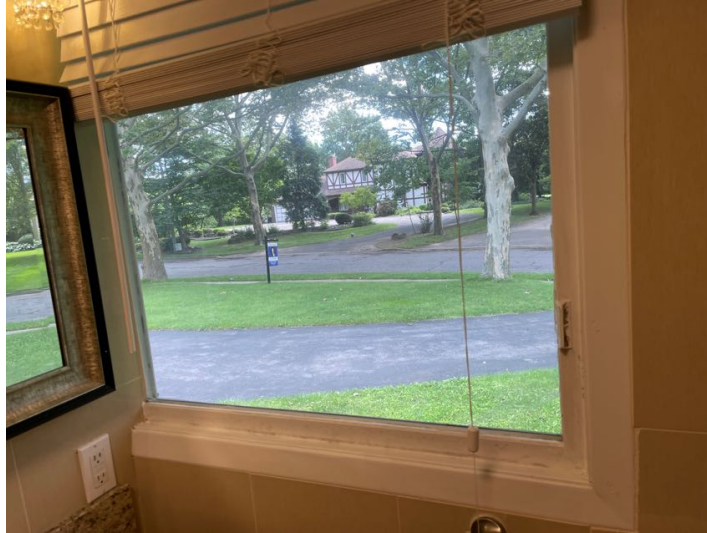
The window has a handle like it should open however, it will not open because this room used to be larger and was constructed so there is a small room on the other side of the bathroom, sharing the same window. This would suggest that there was likely not a permit to put the bathroom in. You may want to check with city hall and see if there was a permit issued for this renovation.
